NC School District/520 Jones County/High School

Jones Senior High

Campus Assessment Report

March 11, 2017

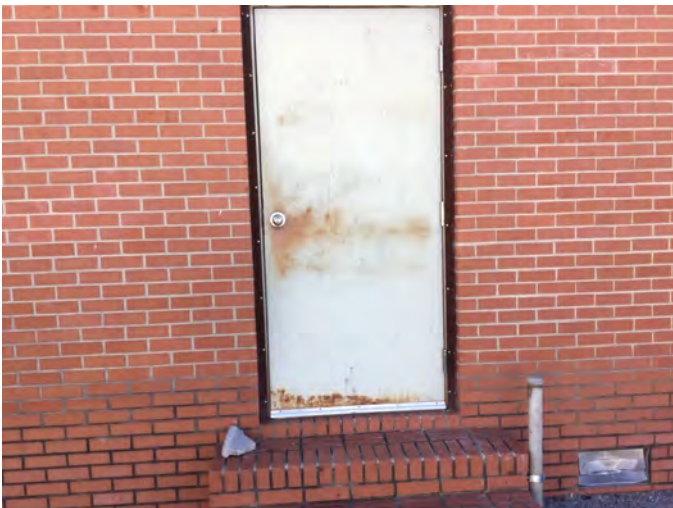
System: B2030 - Exterior Doors

Location: Exterior doors
Distress: Beyond Service Life
Category: Deferred Maintenance
Priority: 3 - Necessary/Not Yet Critical (Years 2-5)
Correction: Renew System
Qty: 1,000.00
Unit of Measure: S.F.
Estimate: \$9,526.00
Assessor Name: Ann Buerger Linden
Date Created: 02/17/2017

Notes: Exterior doors are rusted, poor condition, and beyond their expected useful life. Provide proper exterior landings. System renewal is recommended.

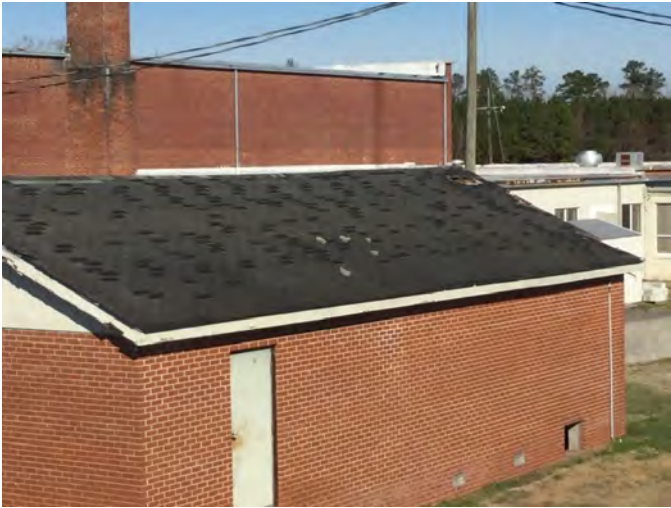
System: B3010140 - Asphalt Shingles

Location: Roof
Distress: Beyond Service Life
Category: Deferred Maintenance
Priority: 3 - Necessary/Not Yet Critical (Years 2-5)
Correction: Renew System
Qty: 1,000.00
Unit of Measure: S.F.
Estimate: \$6,307.00
Assessor Name: Ann Buerger Linden
Date Created: 02/17/2017

Notes: Asphalt shingles are beyond their expected life and leaking. System renewal is recommended.

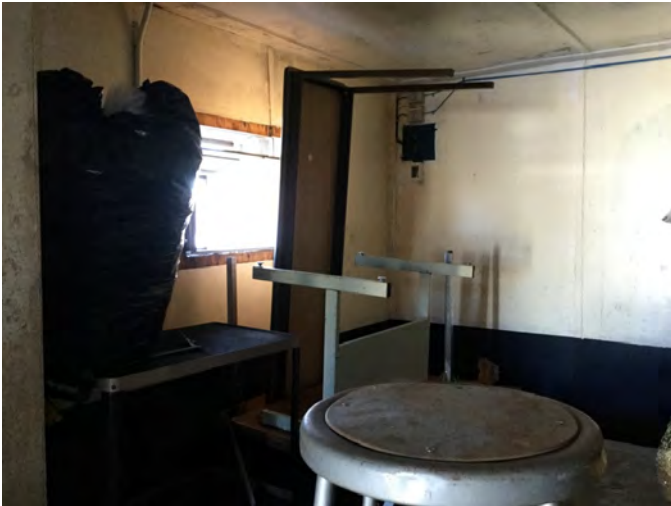
System: C3010 - Wall Finishes

Location: Throughout the building
Distress: Beyond Service Life
Category: Deferred Maintenance
Priority: 3 - Necessary/Not Yet Critical (Years 2-5)
Correction: Renew System
Qty: 1,000.00
Unit of Measure: S.F.
Estimate: \$5,621.00
Assessor Name: Ann Buerger Linden
Date Created: 02/17/2017

Notes: Wall finishes are in poor condition. System renewal is recommended.

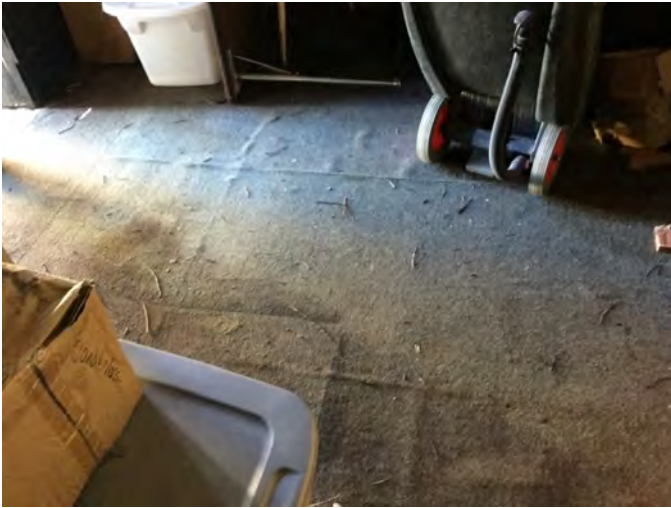
System: C3020 - Floor Finishes

Location: Throughout the building
Distress: Beyond Service Life
Category: Deferred Maintenance
Priority: 3 - Necessary/Not Yet Critical (Years 2-5)
Correction: Renew System
Qty: 1,000.00
Unit of Measure: S.F.
Estimate: \$22,902.00
Assessor Name: Ann Buerger Linden
Date Created: 02/17/2017

Notes: Floor finishes are in poor condition. System renewal is recommended.

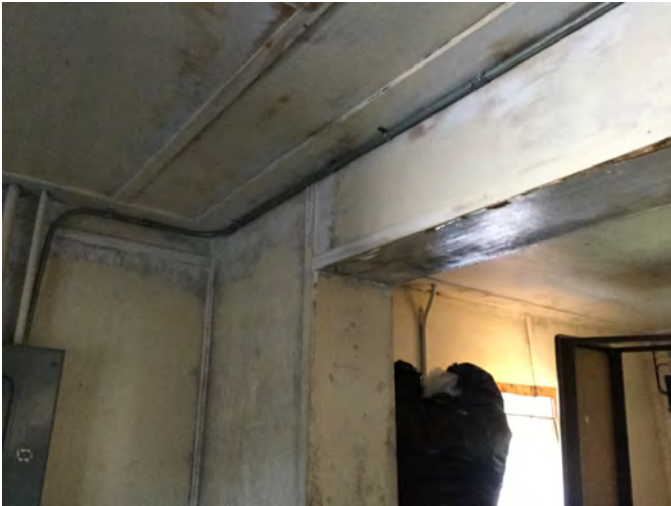
System: C3030 - Ceiling Finishes

Location: Throughout the building
Distress: Beyond Service Life
Category: Deferred Maintenance
Priority: 3 - Necessary/Not Yet Critical (Years 2-5)
Correction: Renew System
Qty: 1,000.00
Unit of Measure: S.F.
Estimate: \$20,636.00
Assessor Name: Ann Buerger Linden
Date Created: 02/17/2017

Notes: Ceilings are in poor condition with considerable water damage. System renewal is recommended.

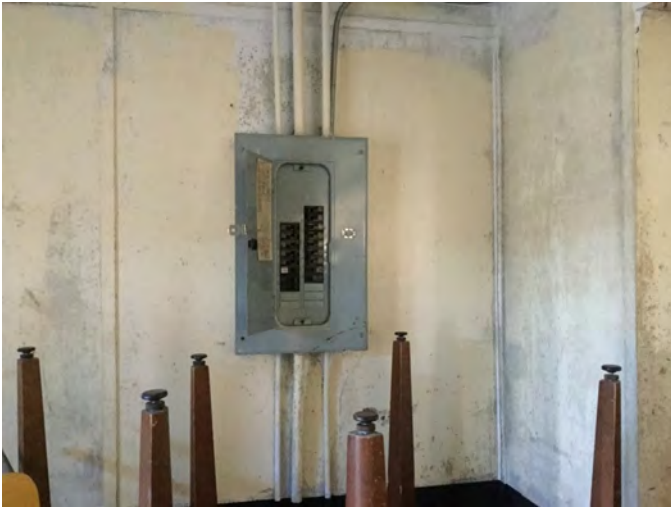
System: D5020 - Branch Wiring

Location: Throughout the building
Distress: Beyond Service Life
Category: Deferred Maintenance
Priority: 3 - Necessary/Not Yet Critical (Years 2-5)
Correction: Renew System
Qty: 1,000.00
Unit of Measure: S.F.
Estimate: \$3,938.00
Assessor Name: Ann Buerger Linden
Date Created: 02/17/2017

Notes: The branch wiring system is beyond its expected useful life. The building was shut down at the time of assessment. System renewal is recommended.

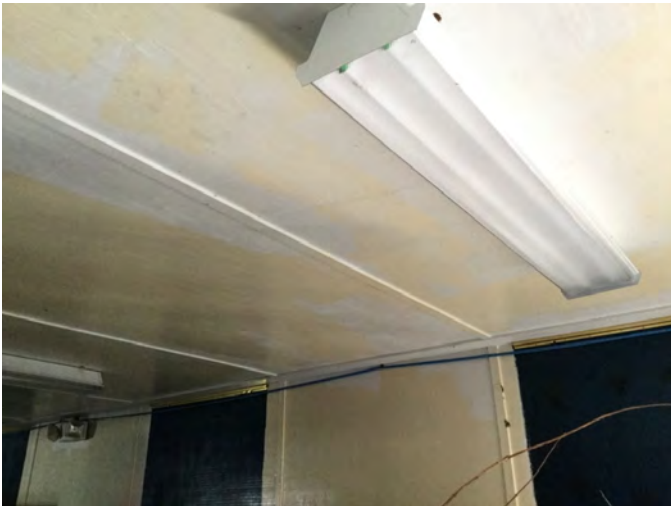
System: D5020 - Lighting

Location: Throught the building
Distress: Beyond Service Life
Category: Deferred Maintenance
Priority: 3 - Necessary/Not Yet Critical (Years 2-5)
Correction: Renew System
Qty: 1,000.00
Unit of Measure: S.F.
Estimate: \$10,538.00
Assessor Name: Ann Buerger Linden
Date Created: 02/17/2017

Notes: Lighting systems are beyond their expected useful life. System renewal is recommended.

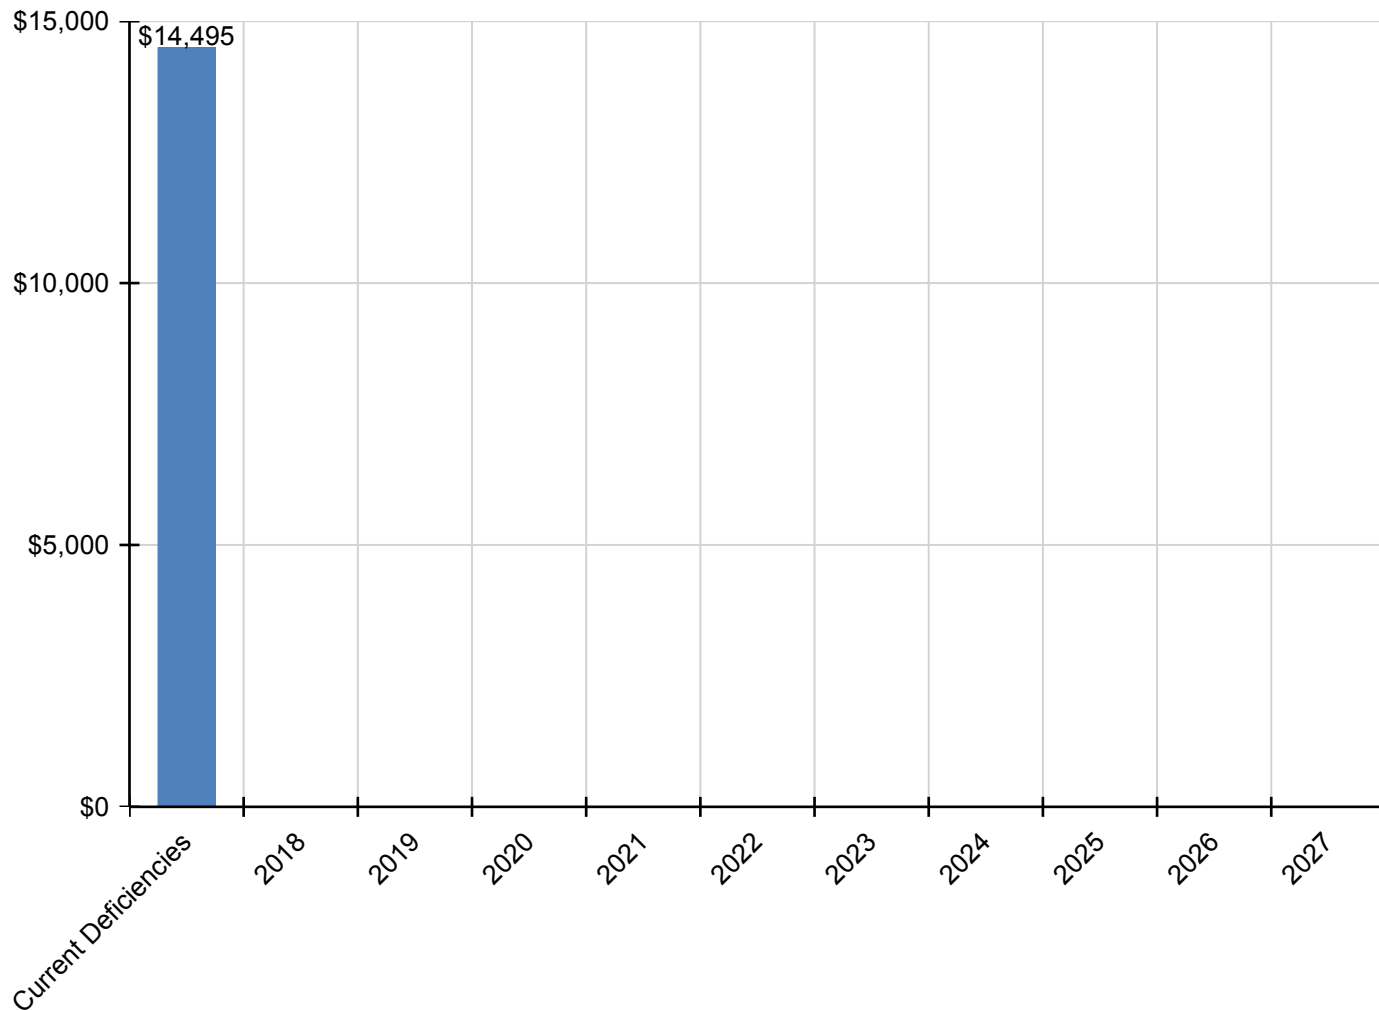
Forecasted Capital Renewal Requirement

The following chart shows the current building deficiencies and forecasting capital renewal or sustainment requirements over the next ten years.

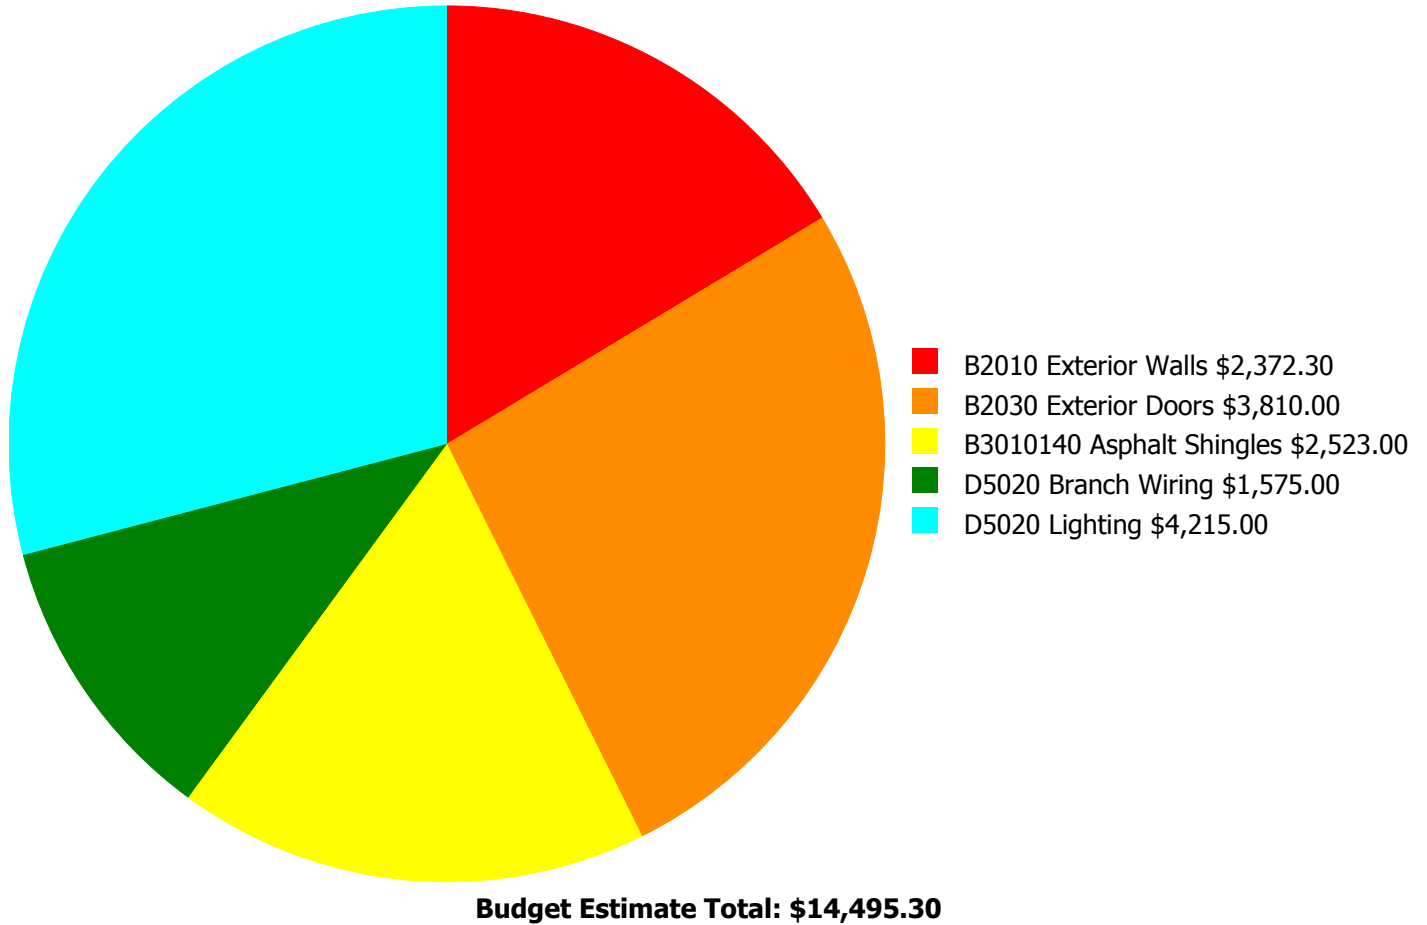
Deficiency Summary by System

Current deficiencies included assemblies that have reached or exceeded their design life or components of the assemblies that are in need of repair. Assemblies that have reached their design life are identified as current deficiencies and assigned the distress 'Beyond Useful Life'. The following chart lists all current deficiencies associated with this facility.

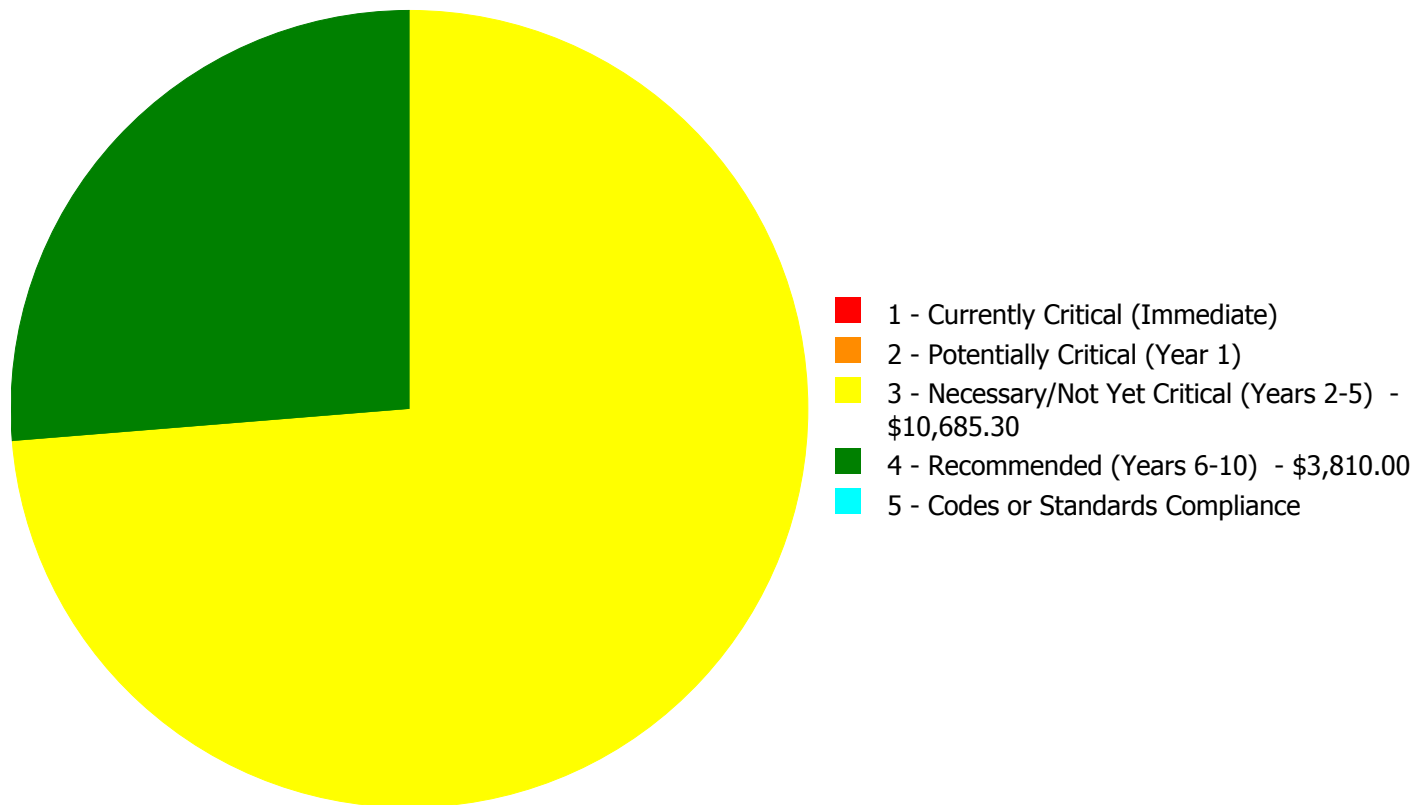
Deficiency Summary by Priority

The following chart shows the total repair costs broken down by priority. Assessors assigned deficiencies within eCOMET to one of the following priority categories:

Budget Estimate Total: \$14,495.30

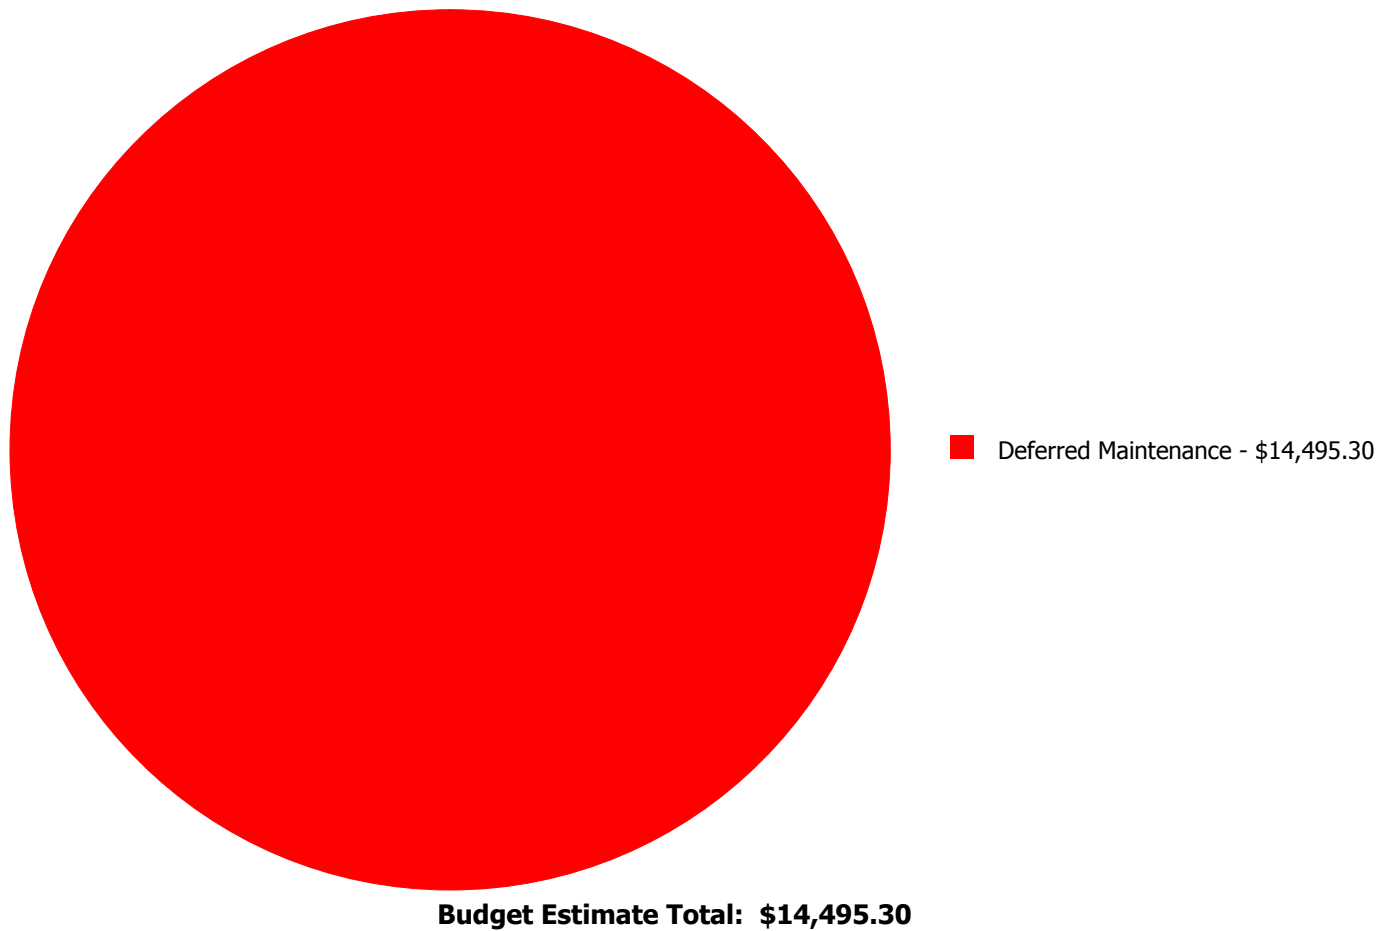
Deficiency Summary by Category

The following chart shows the total repair costs broken down by deficiency categories. Assessors assigned deficiencies to one of the following categories:

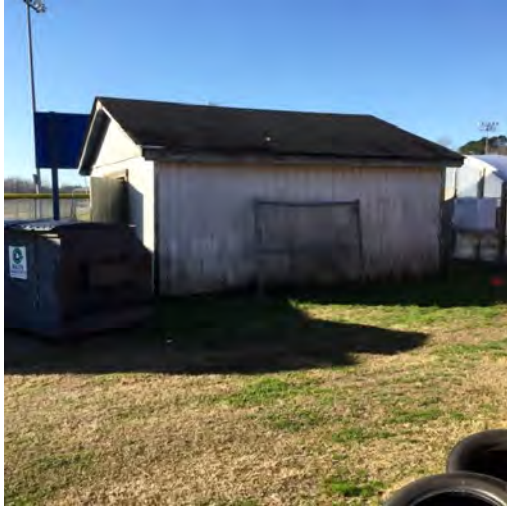
System: B2010 - Exterior Walls

Location: Exterior
Distress: Beyond Service Life
Category: Deferred Maintenance
Priority: 3 - Necessary/Not Yet Critical (Years 2-5)
Correction: Replace & finish wood clapboards, 1st floor
Qty: 5.00
Unit of Measure: C.S.F.
Estimate: \$2,372.30
Assessor Name: Ann Buerger Linden
Date Created: 02/22/2017

Notes: Exterior walls are deteriorated, particularly close to grade. Replacement of damaged siding, fascia boards, and painting is recommended.

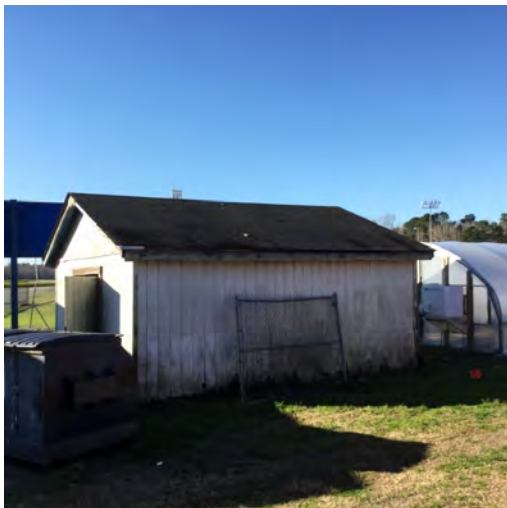
System: B3010140 - Asphalt Shingles

Location: Roof
Distress: Beyond Service Life
Category: Deferred Maintenance
Priority: 3 - Necessary/Not Yet Critical (Years 2-5)
Correction: Renew System
Qty: 400.00
Unit of Measure: S.F.
Estimate: \$2,523.00
Assessor Name: Ann Buerger Linden
Date Created: 02/22/2017

Notes: Roof shingles are in poor condition. System renewal is recommended.

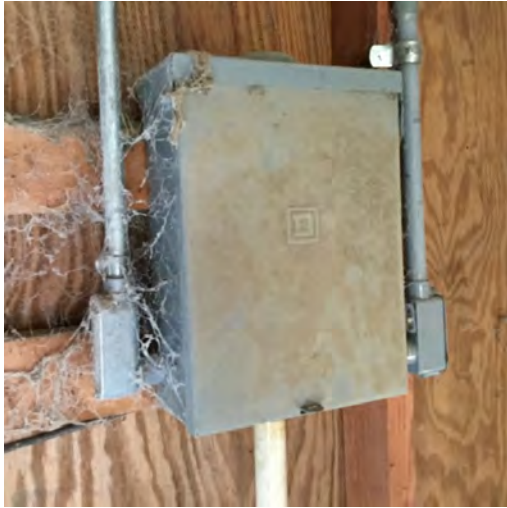
System: D5020 - Branch Wiring

Location: Interior
Distress: Beyond Service Life
Category: Deferred Maintenance
Priority: 3 - Necessary/Not Yet Critical (Years 2-5)
Correction: Renew System
Qty: 400.00
Unit of Measure: S.F.
Estimate: \$1,575.00
Assessor Name: Ann Buerger Linden
Date Created: 02/22/2017

Notes: The branch wiring system is beyond its expected life. System renewal is recommended.

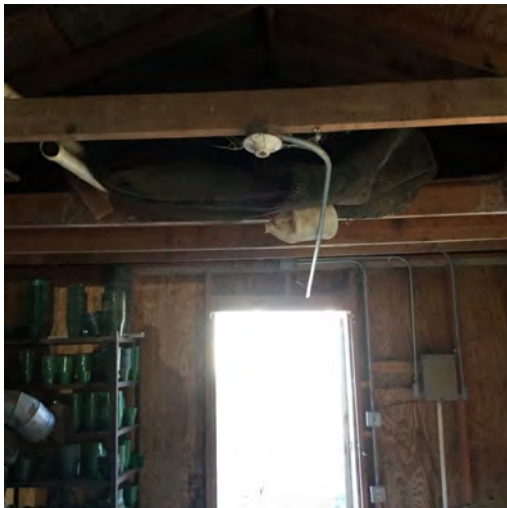
System: D5020 - Lighting

Location: Ceiling
Distress: Beyond Service Life
Category: Deferred Maintenance
Priority: 3 - Necessary/Not Yet Critical (Years 2-5)
Correction: Renew System
Qty: 400.00
Unit of Measure: S.F.
Estimate: \$4,215.00
Assessor Name: Ann Buerger Linden
Date Created: 02/22/2017

Notes: The lighting in this building is not functional. System renewal is recommended.

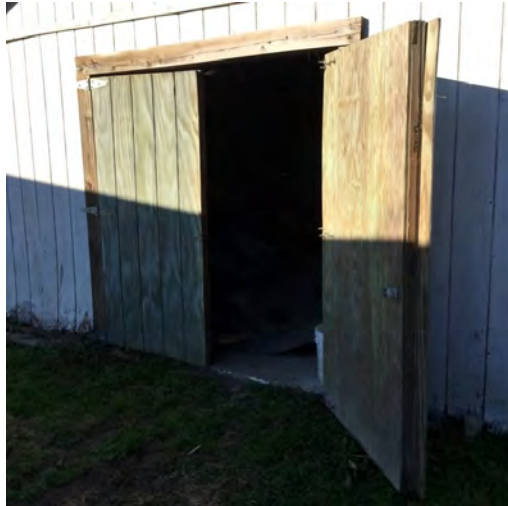
System: B2030 - Exterior Doors

Location: Entrance
Distress: Beyond Service Life
Category: Deferred Maintenance
Priority: 4 - Recommended (Years 6-10)
Correction: Renew System
Qty: 400.00
Unit of Measure: S.F.
Estimate: \$3,810.00
Assessor Name: Ann Buerger Linden
Date Created: 02/22/2017

Notes: The exterior door is in fair condition and beyond its expected life. Replacement is recommended.

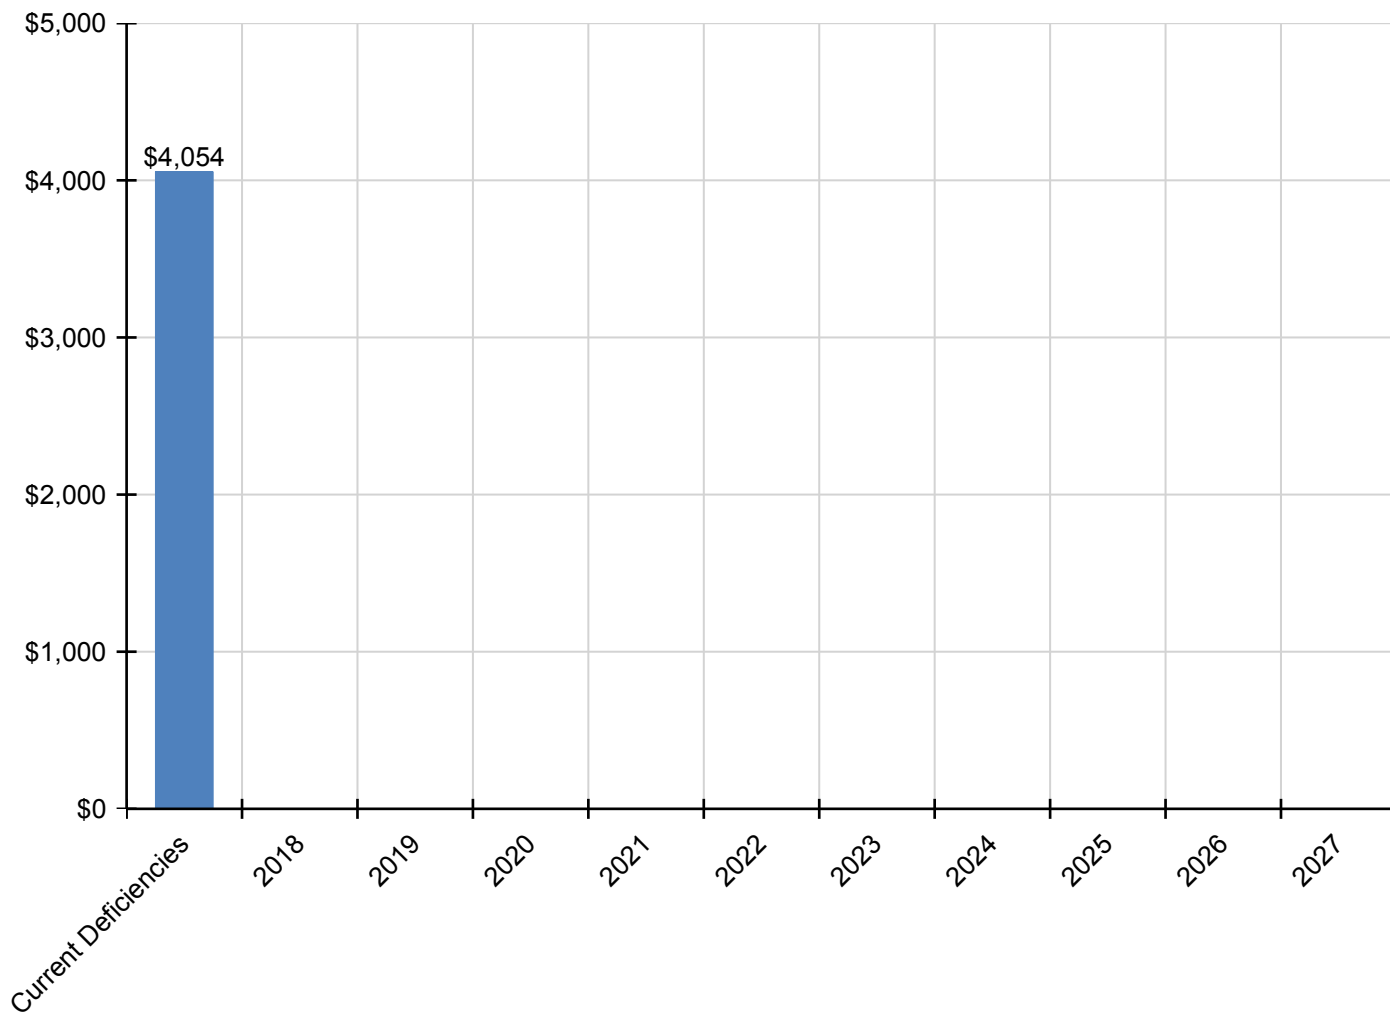
Forecasted Capital Renewal Requirement

The following chart shows the current building deficiencies and forecasting capital renewal or sustainment requirements over the next ten years.

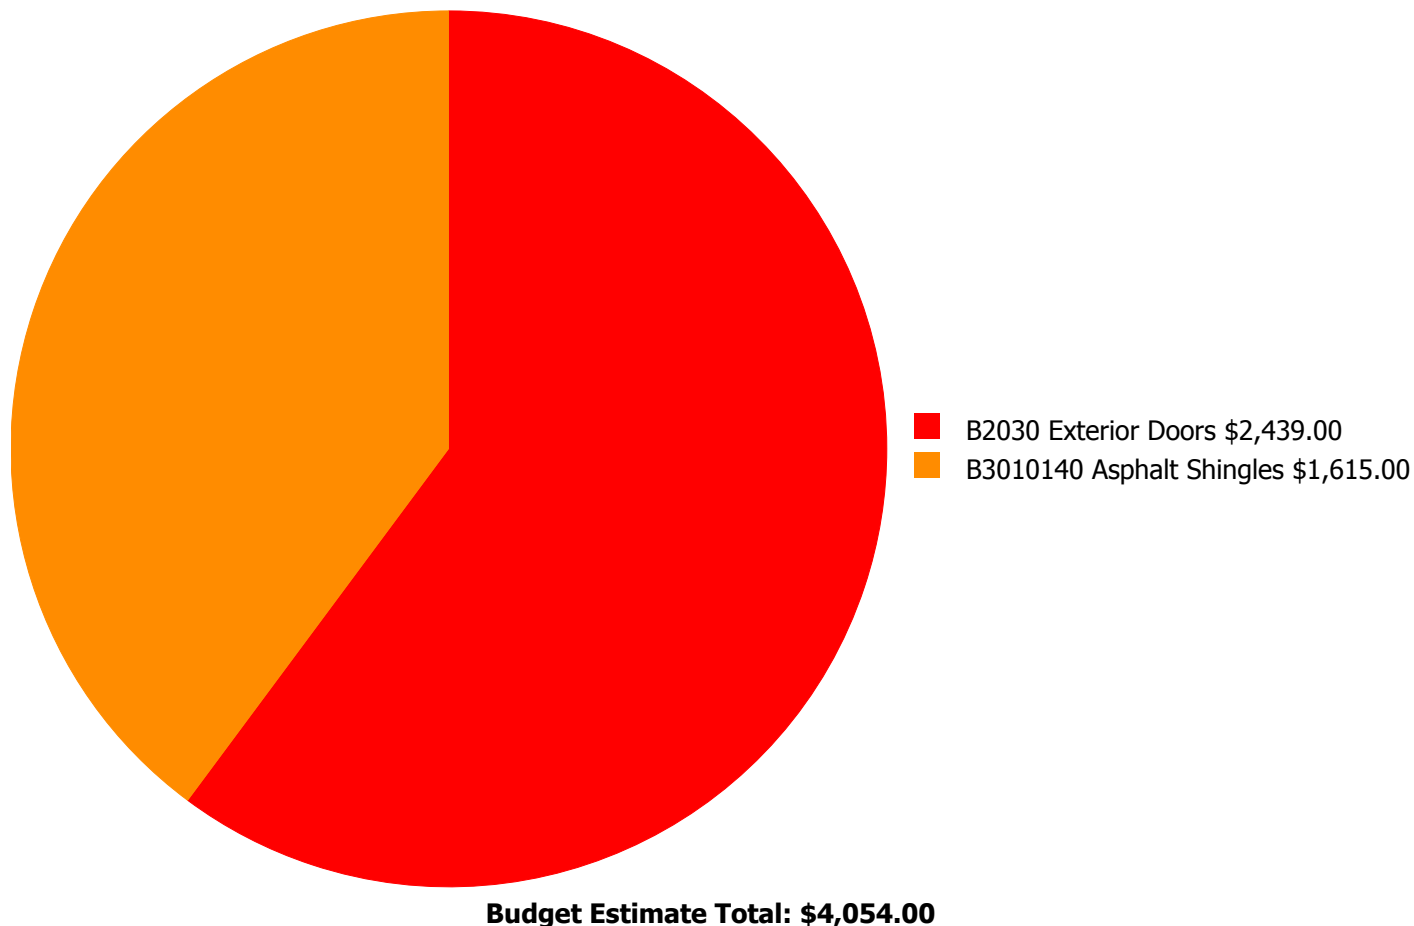
Deficiency Summary by System

Current deficiencies included assemblies that have reached or exceeded their design life or components of the assemblies that are in need of repair. Assemblies that have reached their design life are identified as current deficiencies and assigned the distress 'Beyond Useful Life'. The following chart lists all current deficiencies associated with this facility.

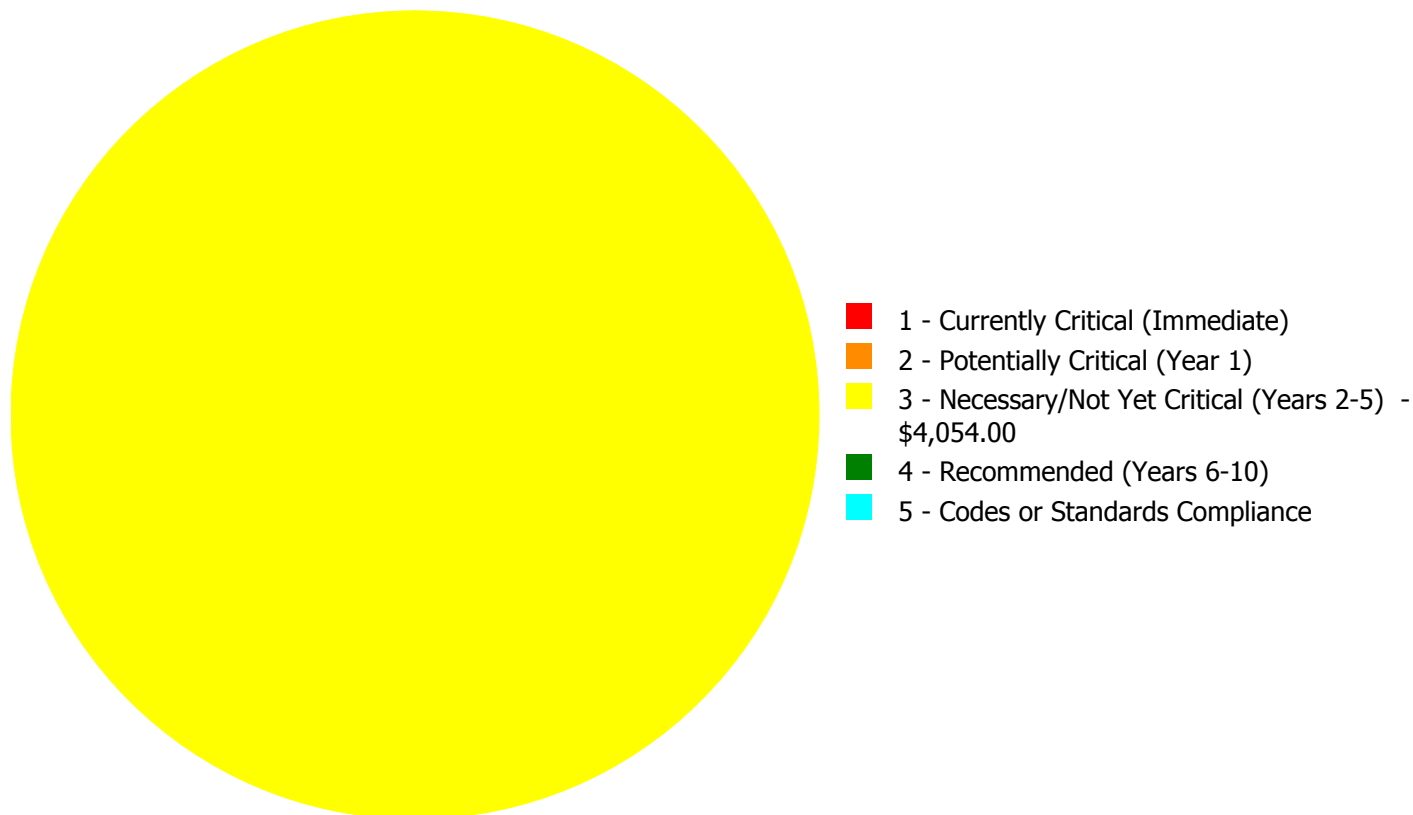
Deficiency Summary by Priority

The following chart shows the total repair costs broken down by priority. Assessors assigned deficiencies within eCOMET to one of the following priority categories:

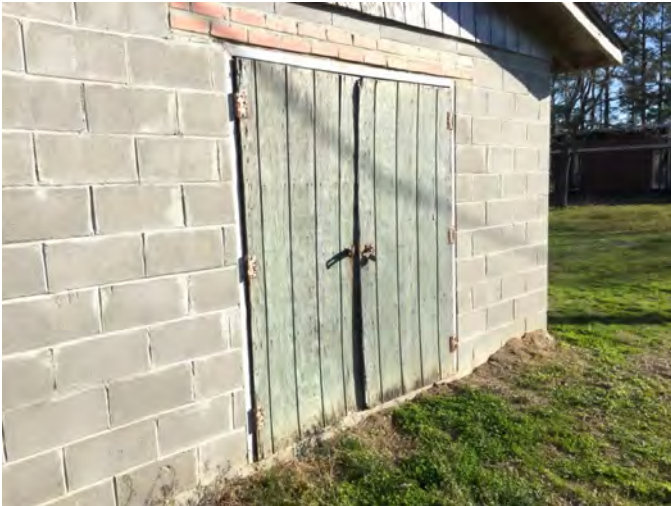
System: B2030 - Exterior Doors

Location: Exterior doors
Distress: Beyond Service Life
Category: Deferred Maintenance
Priority: 3 - Necessary/Not Yet Critical (Years 2-5)
Correction: Renew System
Qty: 256.00
Unit of Measure: S.F.
Estimate: \$2,439.00
Assessor Name: Ann Buerger Linden
Date Created: 02/17/2017

Notes: Exterior doors are in weathered condition. System renewal is recommended.

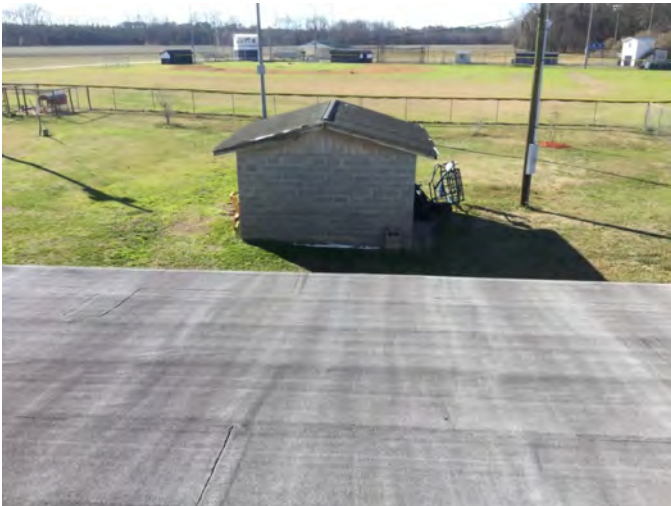
System: B3010140 - Asphalt Shingles

Location: Roof
Distress: Beyond Service Life
Category: Deferred Maintenance
Priority: 3 - Necessary/Not Yet Critical (Years 2-5)
Correction: Renew System
Qty: 256.00
Unit of Measure: S.F.
Estimate: \$1,615.00
Assessor Name: Ann Buerger Linden
Date Created: 02/17/2017

Notes: Asphalt shingles are in poor condition. System renewal is recommended.

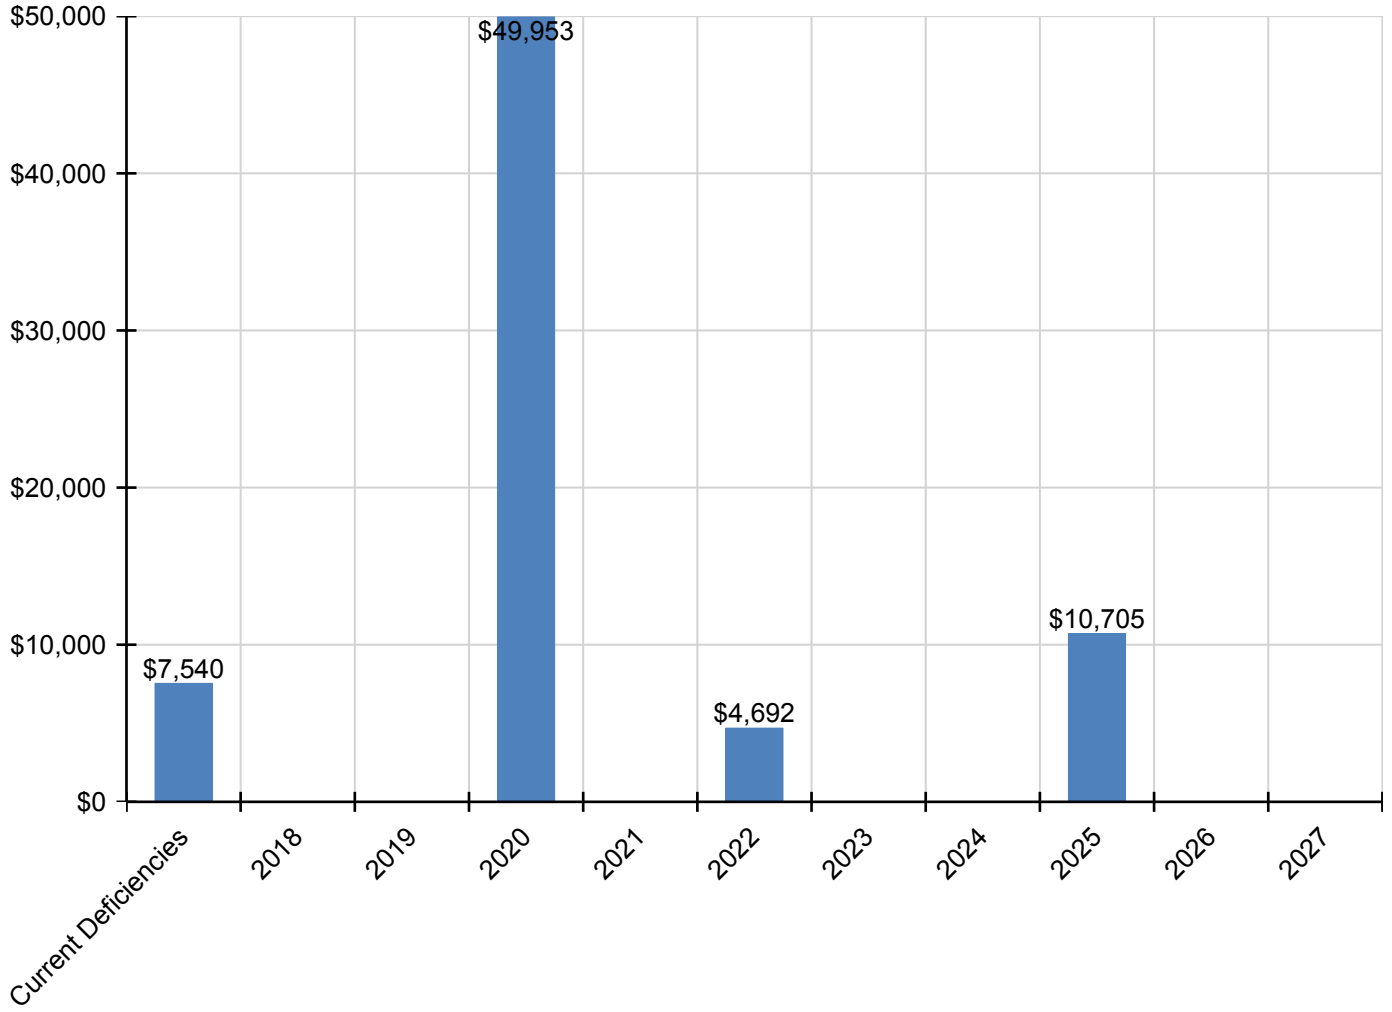
Forecasted Capital Renewal Requirement

The following chart shows the current building deficiencies and forecasting capital renewal or sustainment requirements over the next ten years.

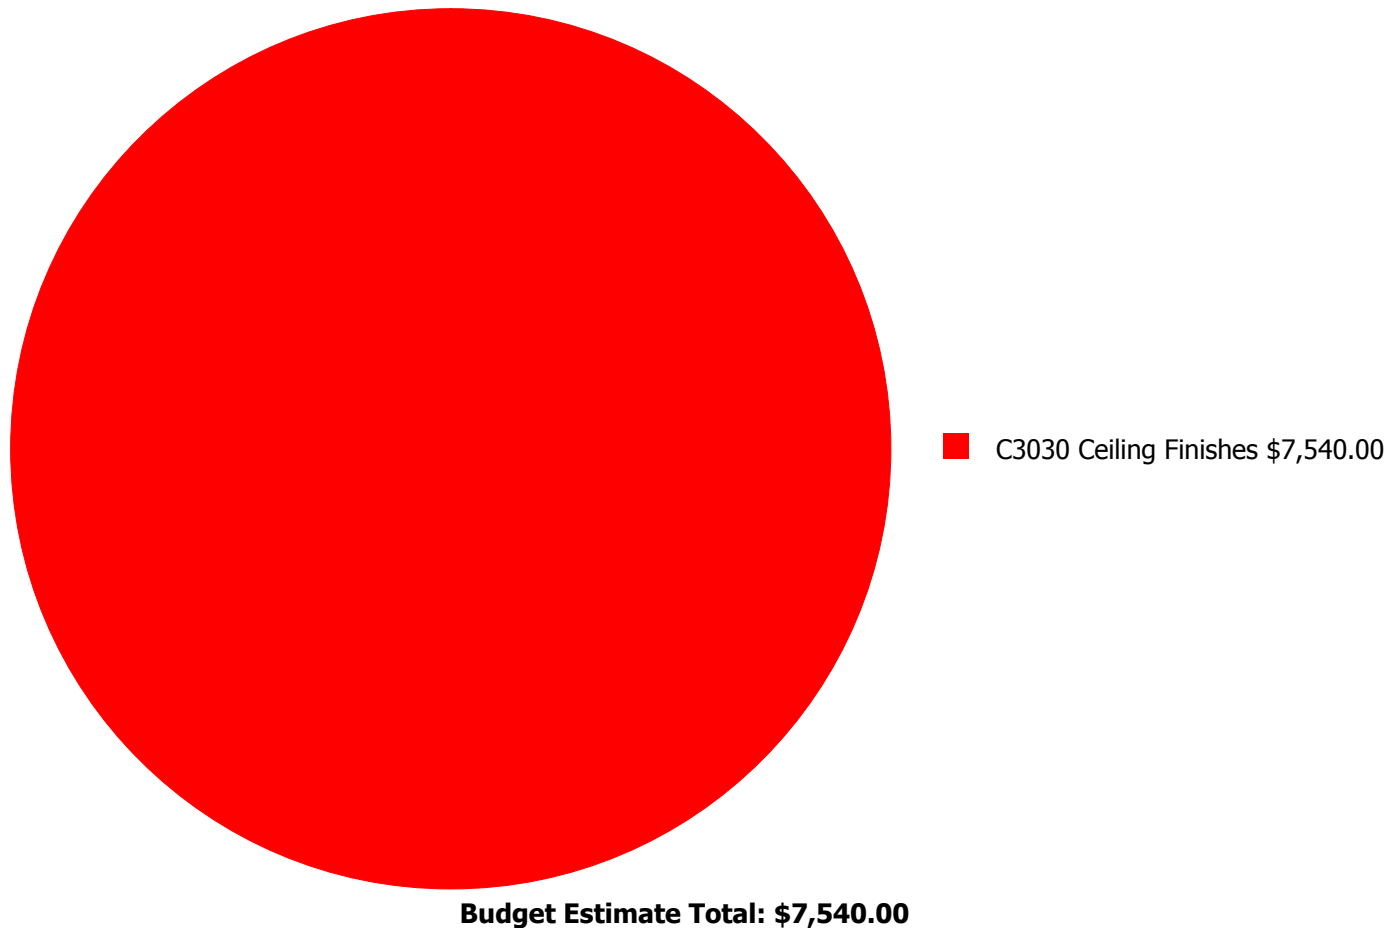
Deficiency Summary by System

Current deficiencies included assemblies that have reached or exceeded their design life or components of the assemblies that are in need of repair. Assemblies that have reached their design life are identified as current deficiencies and assigned the distress 'Beyond Useful Life'. The following chart lists all current deficiencies associated with this facility.

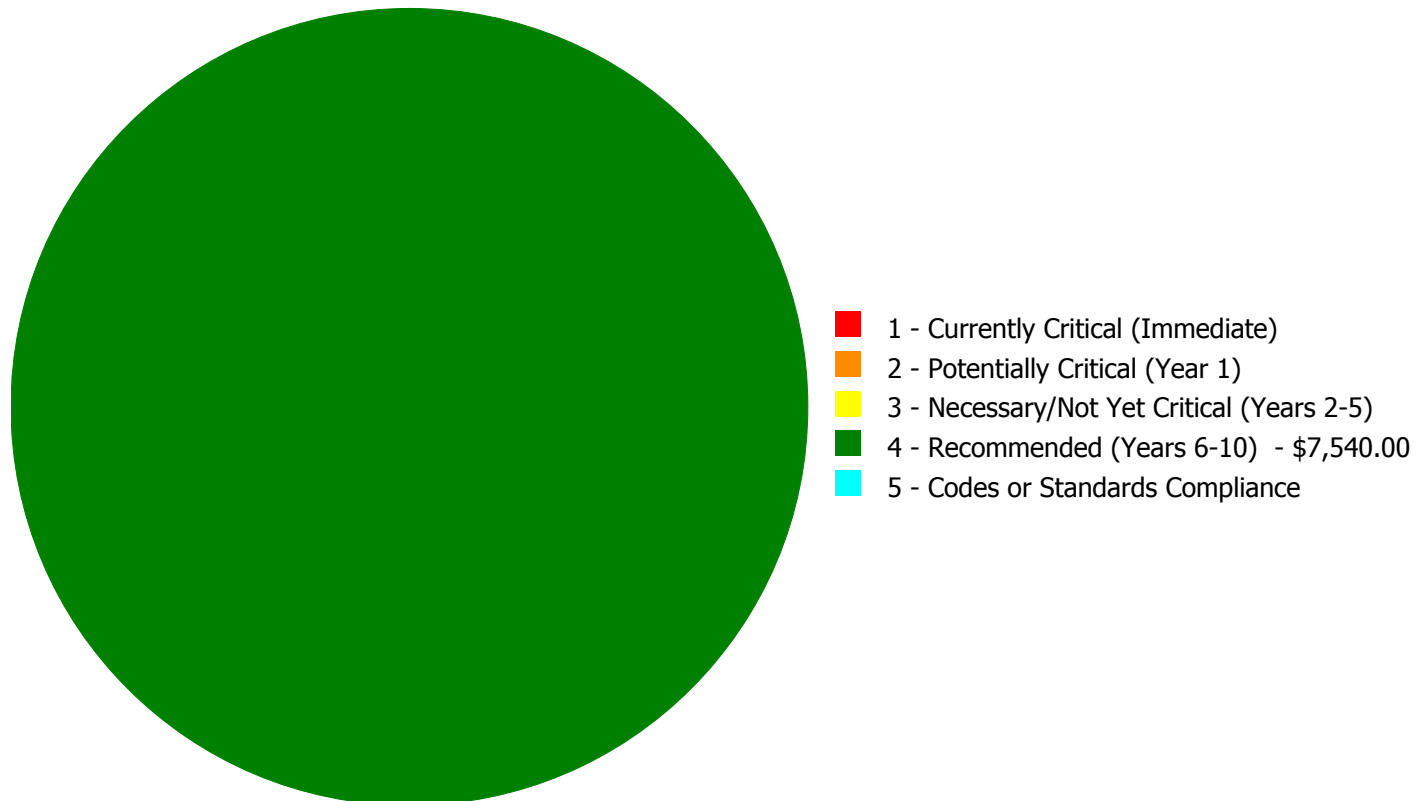
Deficiency Summary by Priority

The following chart shows the total repair costs broken down by priority. Assessors assigned deficiencies within eCOMET to one of the following priority categories:

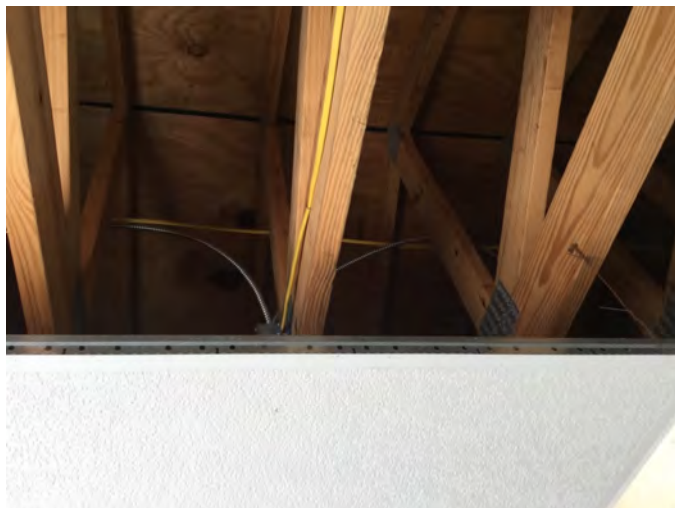
System: C3030 - Ceiling Finishes

Location: Interior ceilings
Distress: Beyond Service Life
Category: Deferred Maintenance
Priority: 4 - Recommended (Years 6-10)
Correction: Renew System
Qty: 720.00
Unit of Measure: S.F.
Estimate: \$7,540.00
Assessor Name: Ann Buerger Linden
Date Created: 02/17/2017

Notes: Interior ceilings are in generally fair to good condition with a few missing tiles. System renewal is recommended.

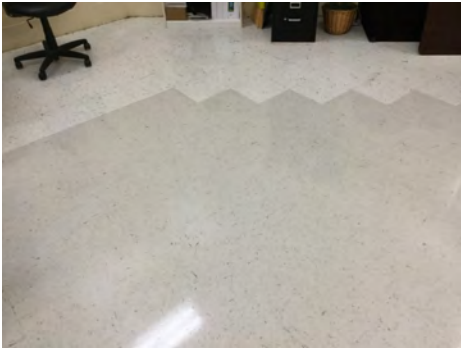
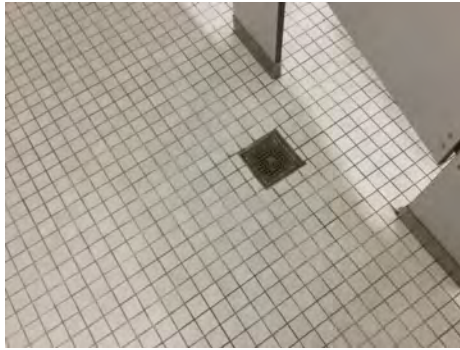
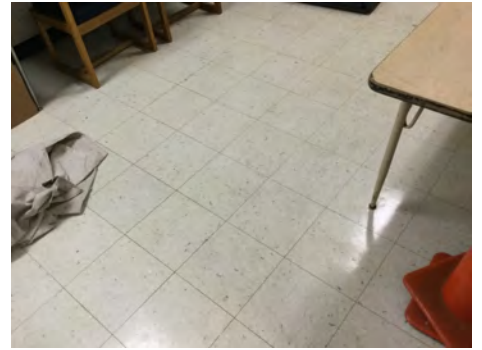
System: C3020 - Floor Finishes

Note: Floor finishes are well maintained in overall good to fair condition. System renewal pushed 5 years.

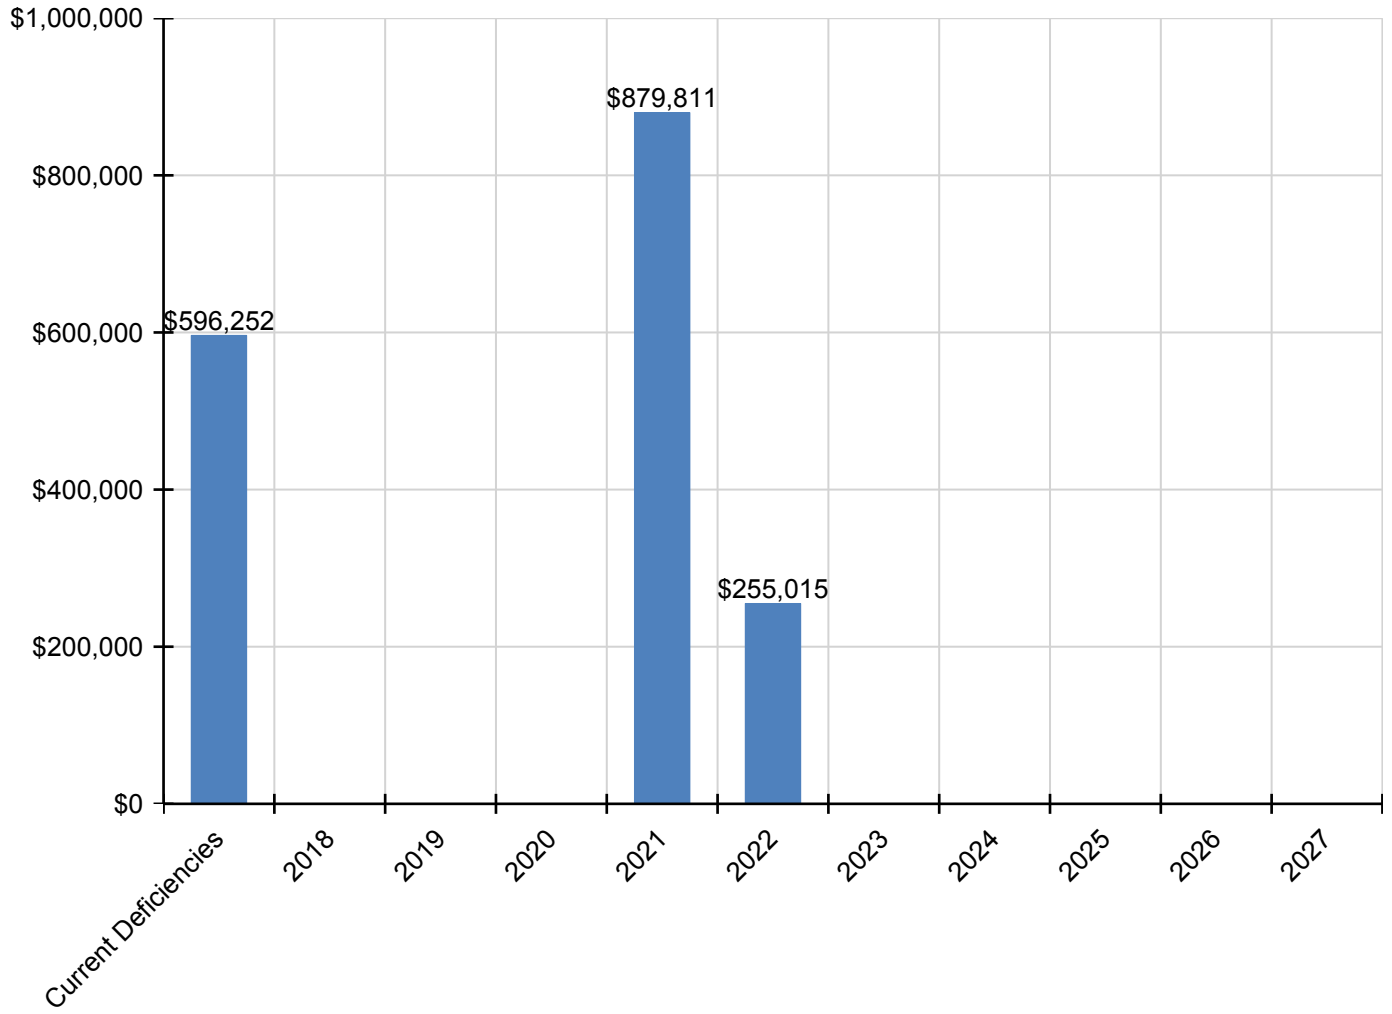
Forecasted Capital Renewal Requirement

The following chart shows the current building deficiencies and forecasting capital renewal or sustainment requirements over the next ten years.
