NC School District/520 Jones County/High School

Jones Senior High

Campus Assessment Report

March 11, 2017

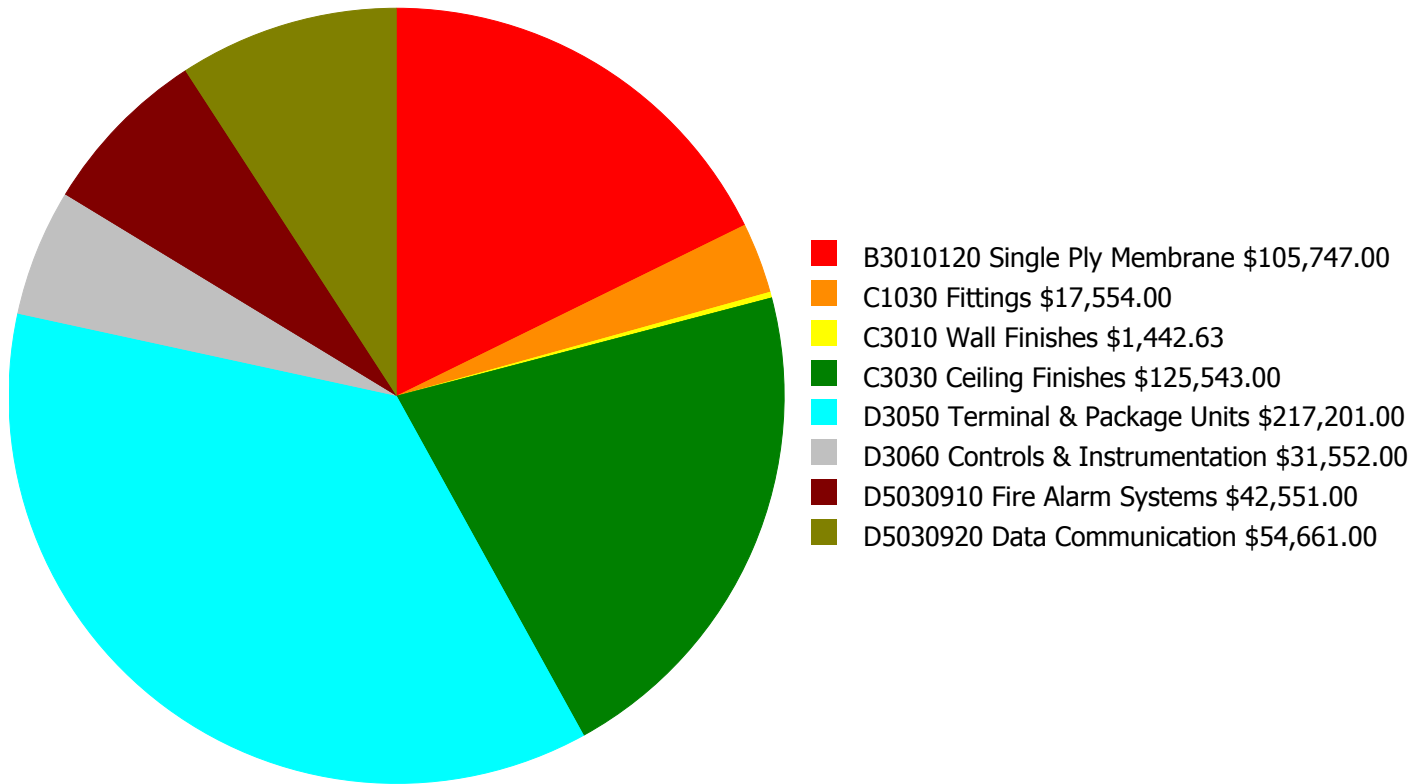
Deficiency Summary by System

Current deficiencies included assemblies that have reached or exceeded their design life or components of the assemblies that are in need of repair. Assemblies that have reached their design life are identified as current deficiencies and assigned the distress 'Beyond Useful Life'. The following chart lists all current deficiencies associated with this facility.

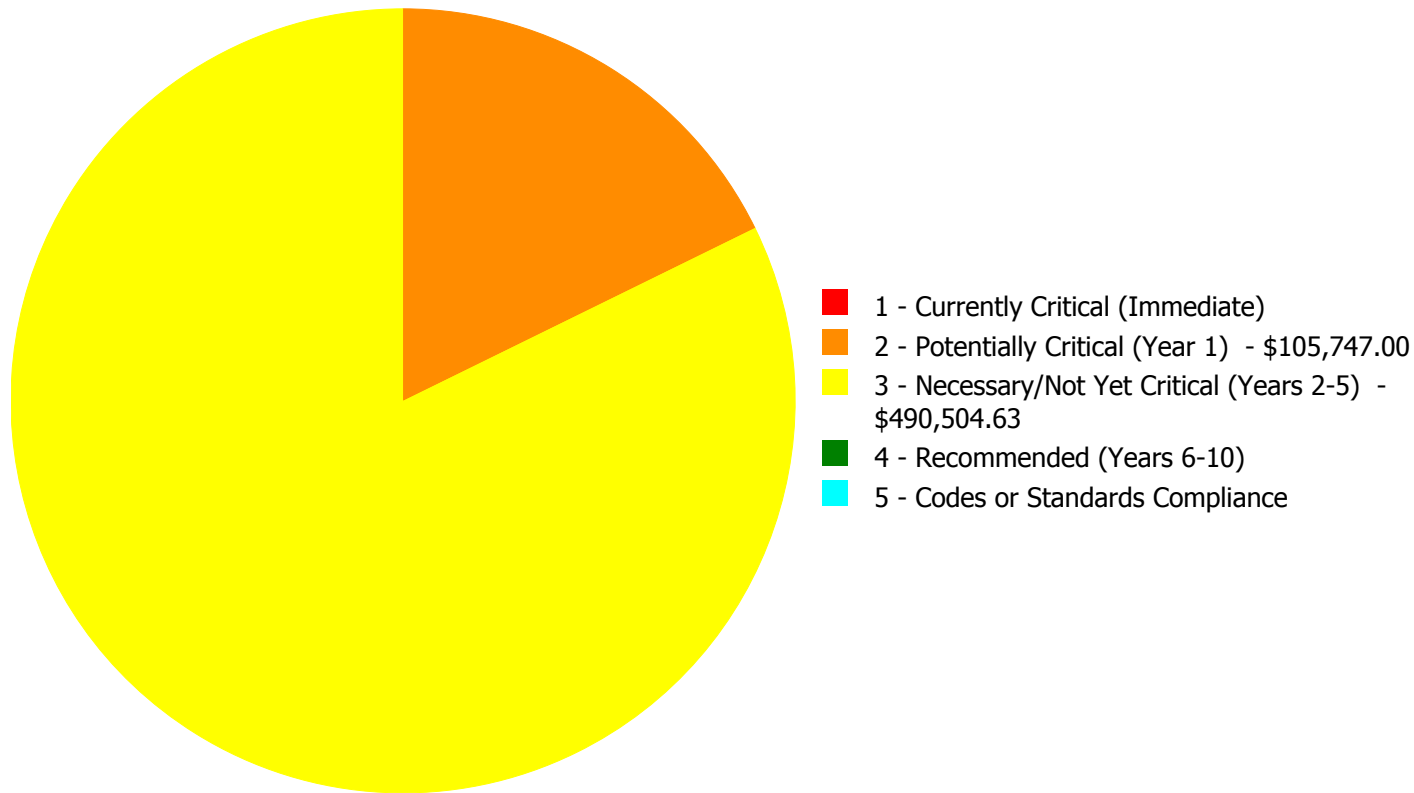
Deficiency Summary by Priority

The following chart shows the total repair costs broken down by priority. Assessors assigned deficiencies within eCOMET to one of the following priority categories:

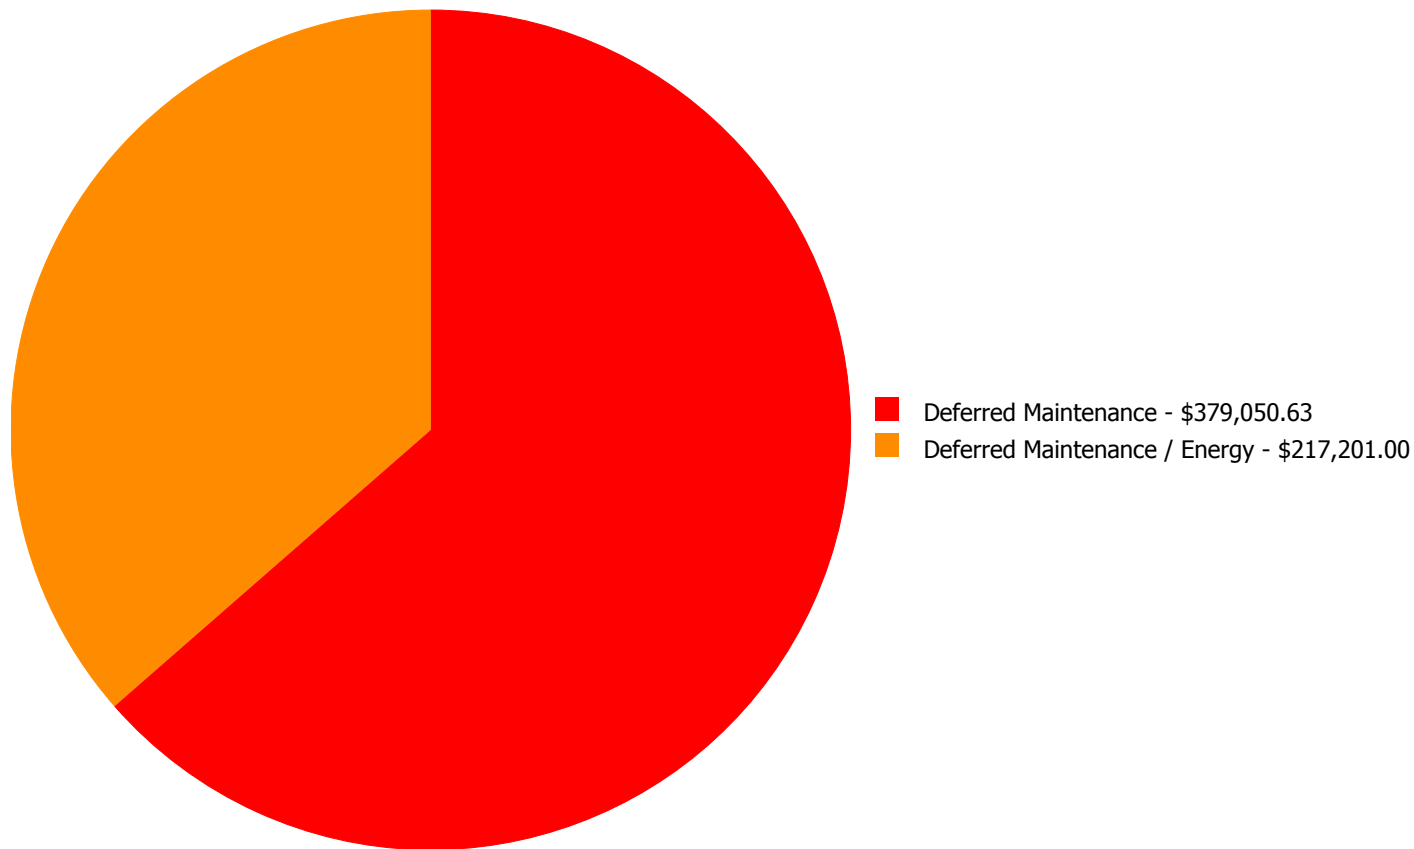
Deficiency Summary by Category

The following chart shows the total repair costs broken down by deficiency categories. Assessors assigned deficiencies to one of the following categories:

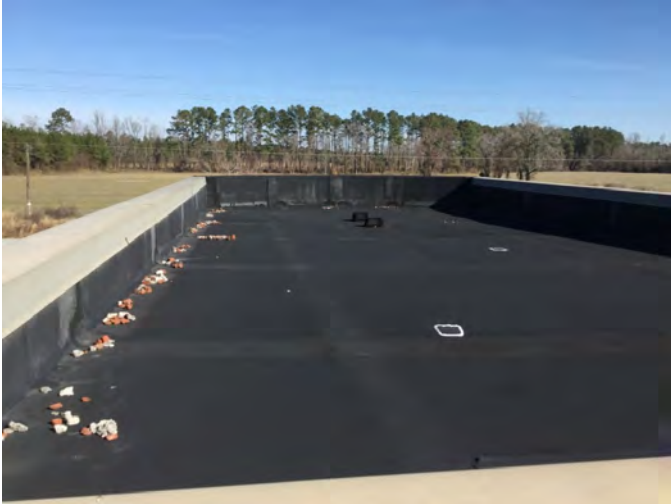
System: B3010120 - Single Ply Membrane

Location: Roofs
Distress: Beyond Service Life
Category: Deferred Maintenance
Priority: 2 - Potentially Critical (Year 1)
Correction: Renew System
Qty: 10,100.00
Unit of Measure: S.F.
Estimate: \$105,747.00
Assessor Name: Terence Davis
Date Created: 02/17/2017

Notes: The original single ply membrane has exceeded its expected useful life. Interior damage to finishes is evident, particularly in the gym lobby and music room portions of the building. System renewal is recommended.

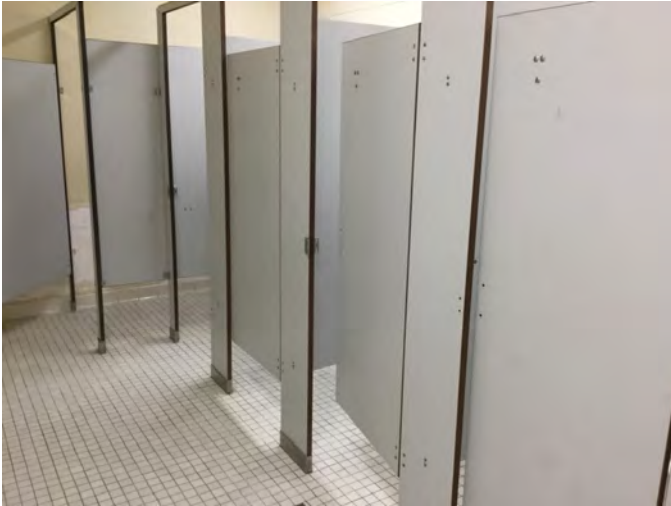
System: C1030 - Fittings

Location: Throughout the building
Distress: Beyond Service Life
Category: Deferred Maintenance
Priority: 3 - Necessary/Not Yet Critical (Years 2-5)
Correction: Renew System
Qty: 10,100.00
Unit of Measure: S.F.
Estimate: \$17,554.00
Assessor Name: Terence Davis
Date Created: 02/17/2017

Notes: Fittings in general are beyond their expected useful life. Toilet partitions and accessories and signage are not ADA compliant. Blackboards are obsolete. System renewal is recommended.

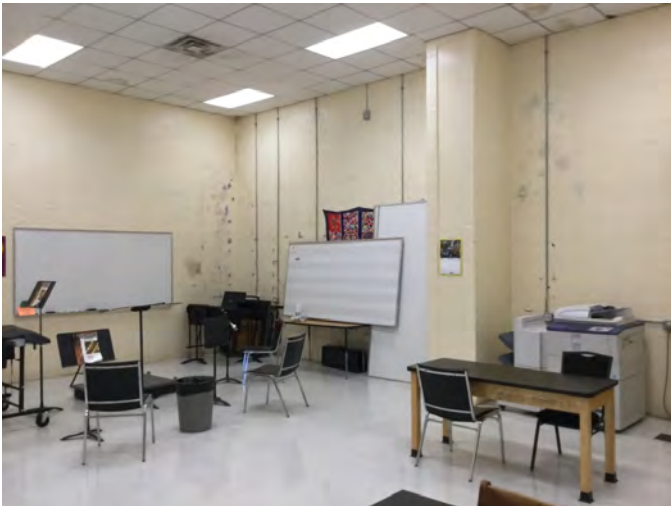
System: C3010 - Wall Finishes

Location: Gym lobby RRs and music room
Distress: Damaged
Category: Deferred Maintenance
Priority: 3 - Necessary/Not Yet Critical (Years 2-5)
Correction: Refinish plaster wall
Qty: 30.00
Unit of Measure: S.Y.
Estimate: \$1,442.63
Assessor Name: Terence Davis
Date Created: 02/24/2017

Notes: Interior wall finishes are generally well maintained. However walls of the toilet rooms that are part of the original exterior wall construction and the music room are affected by roof leaks. Painting, including any necessary prep work, is recommended.

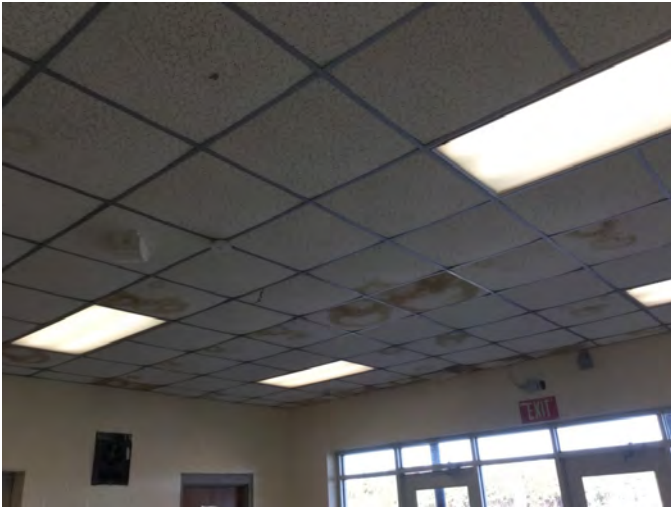
System: C3030 - Ceiling Finishes

Location: Throughout the building
Distress: Beyond Service Life
Category: Deferred Maintenance
Priority: 3 - Necessary/Not Yet Critical (Years 2-5)
Correction: Renew System
Qty: 10,100.00
Unit of Measure: S.F.
Estimate: \$125,543.00
Assessor Name: Terence Davis
Date Created: 02/17/2017

Notes: Ceiling finishes are beyond their useful life. Areas with particularly bad water damage are in the gym lobby addition and the music room. Roof repairs should be undertaken before ceilings are replaced.

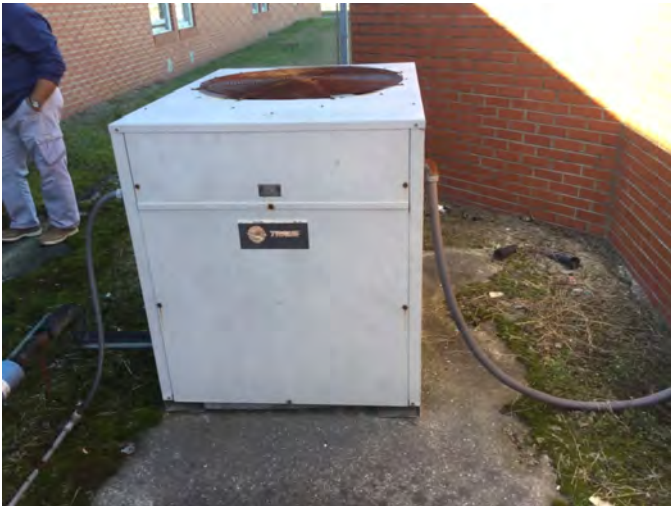
System: D3050 - Terminal & Package Units

Location: Mechanical yard
Distress: Beyond Service Life
Category: Deferred Maintenance / Energy
Priority: 3 - Necessary/Not Yet Critical (Years 2-5)
Correction: Renew System
Qty: 10,100.00
Unit of Measure: S.F.
Estimate: \$217,201.00
Assessor Name: Terence Davis
Date Created: 02/17/2017

Notes: The ground mount condenser units have exceeded their expected useful life. System renewal is recommended.

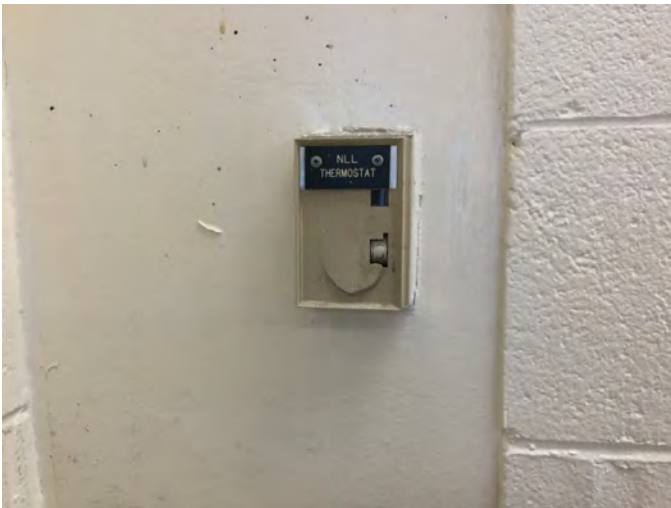
System: D3060 - Controls & Instrumentation

Location: Throughout the building
Distress: Beyond Service Life
Category: Deferred Maintenance
Priority: 3 - Necessary/Not Yet Critical (Years 2-5)
Correction: Renew System
Qty: 10,100.00
Unit of Measure: S.F.
Estimate: \$31,552.00
Assessor Name: Terence Davis
Date Created: 02/17/2017

Notes: Building controls are locally controlled. Installation of a modern digital system with remote monitoring and control capability for energy conservation is recommended.

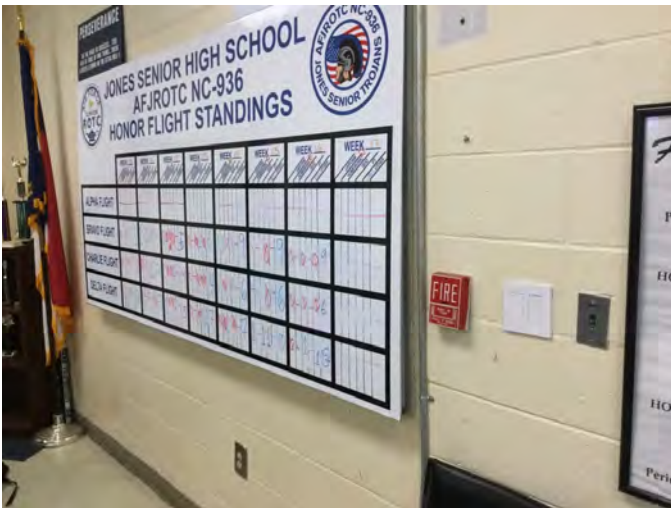
System: D5030910 - Fire Alarm Systems

Location: Throughout the building
Distress: Beyond Service Life
Category: Deferred Maintenance
Priority: 3 - Necessary/Not Yet Critical (Years 2-5)
Correction: Renew System
Qty: 10,100.00
Unit of Measure: S.F.
Estimate: \$42,551.00
Assessor Name: Terence Davis
Date Created: 02/17/2017

Notes: The fire alarm system is original and beyond its expected life. System renewal to current codes is recommended to ensure reliability of this life safety system.

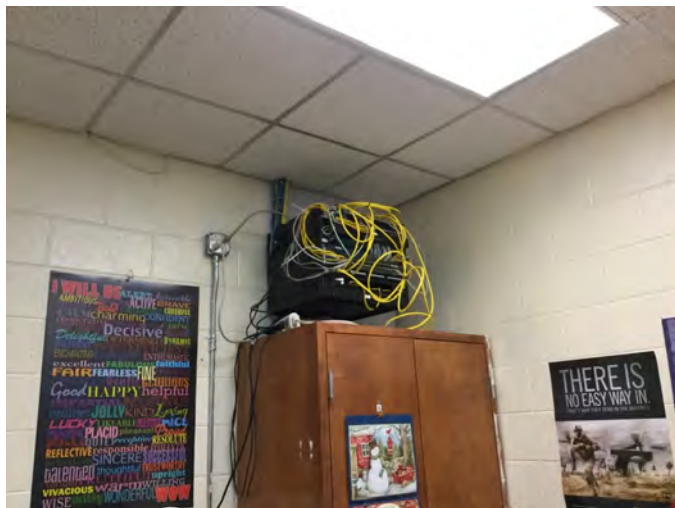
System: D5030920 - Data Communication

Location: Throughout the building
Distress: Beyond Service Life
Category: Deferred Maintenance
Priority: 3 - Necessary/Not Yet Critical (Years 2-5)
Correction: Renew System
Qty: 10,100.00
Unit of Measure: S.F.
Estimate: \$54,661.00
Assessor Name: Terence Davis
Date Created: 02/17/2017

Notes: Data and communications systems are beyond their expected useful life. The PA system is inadequate. System renewal is recommended.

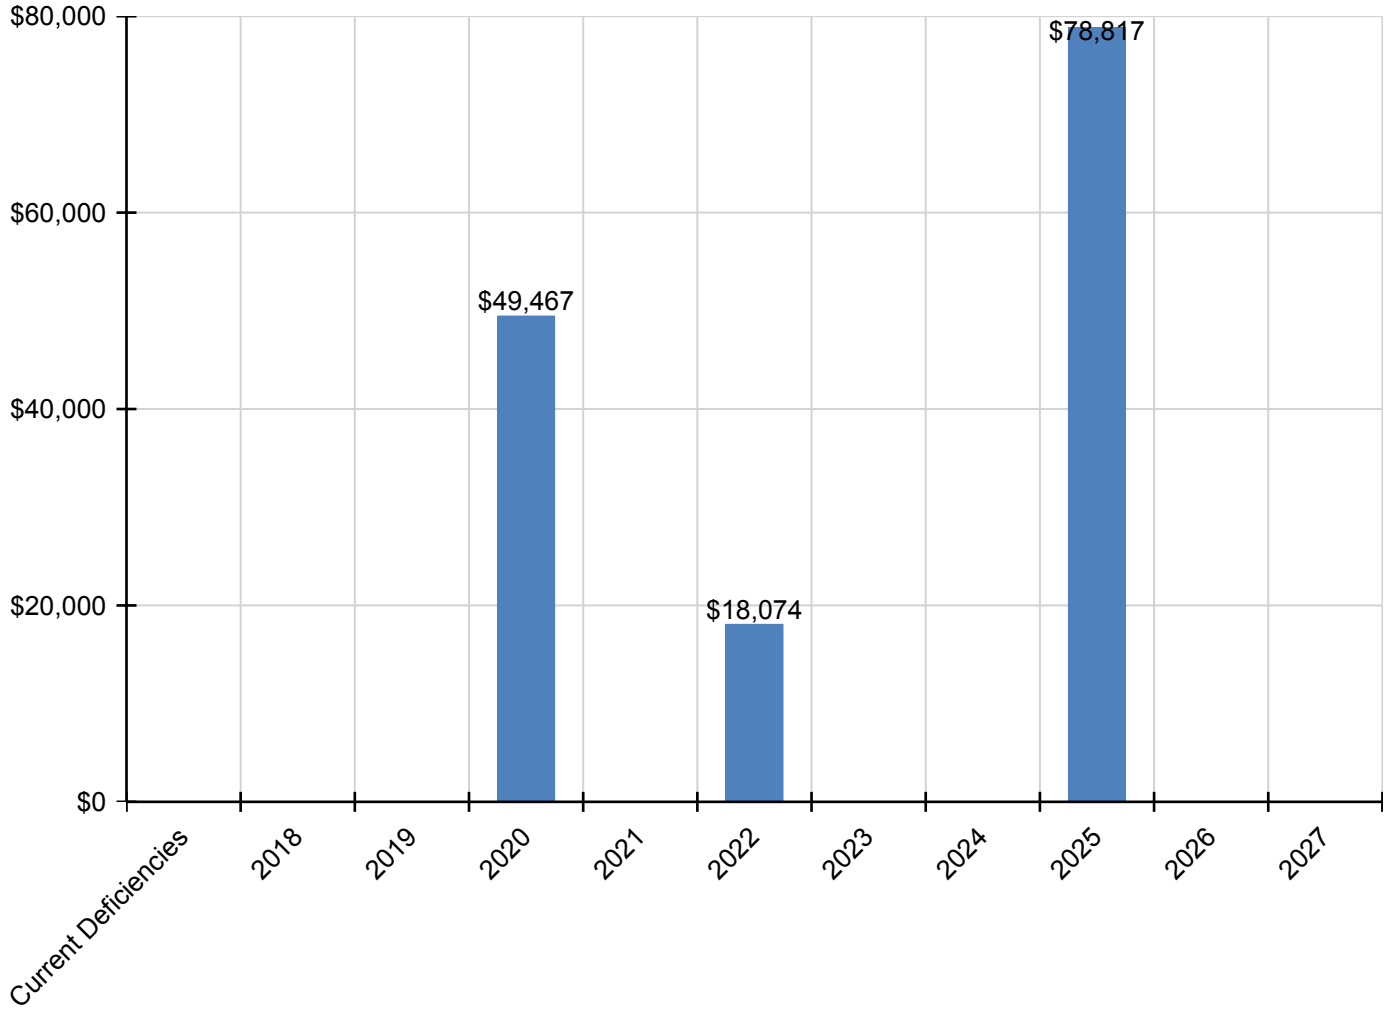
Forecasted Capital Renewal Requirement

The following chart shows the current building deficiencies and forecasting capital renewal or sustainment requirements over the next ten years.

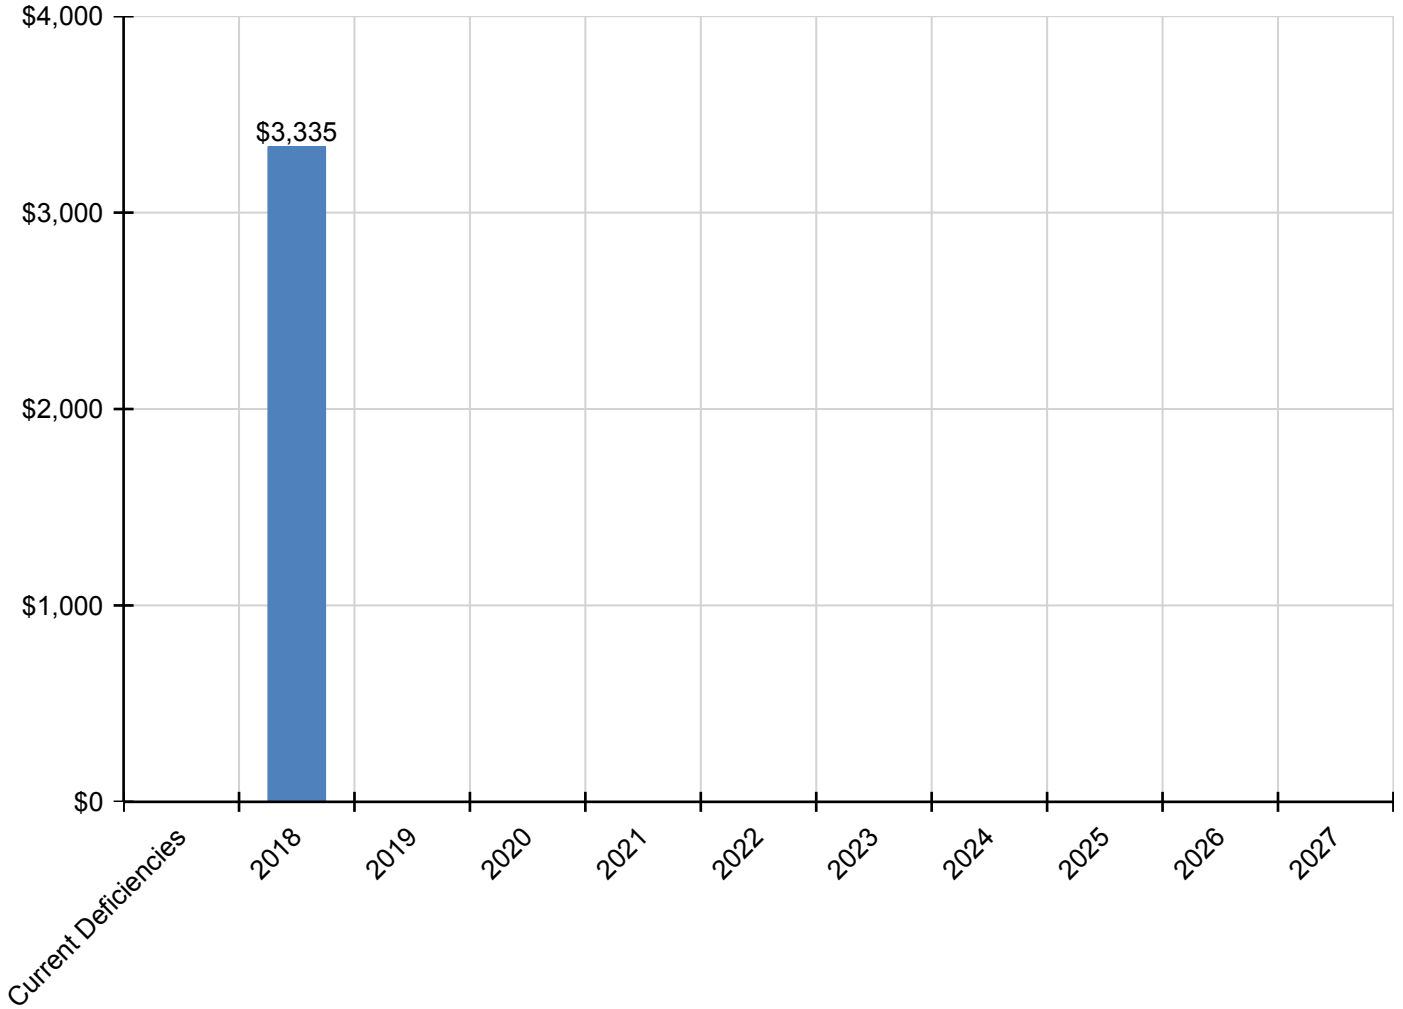
Forecasted Capital Renewal Requirement

The following chart shows the current building deficiencies and forecasting capital renewal or sustainment requirements over the next ten years.

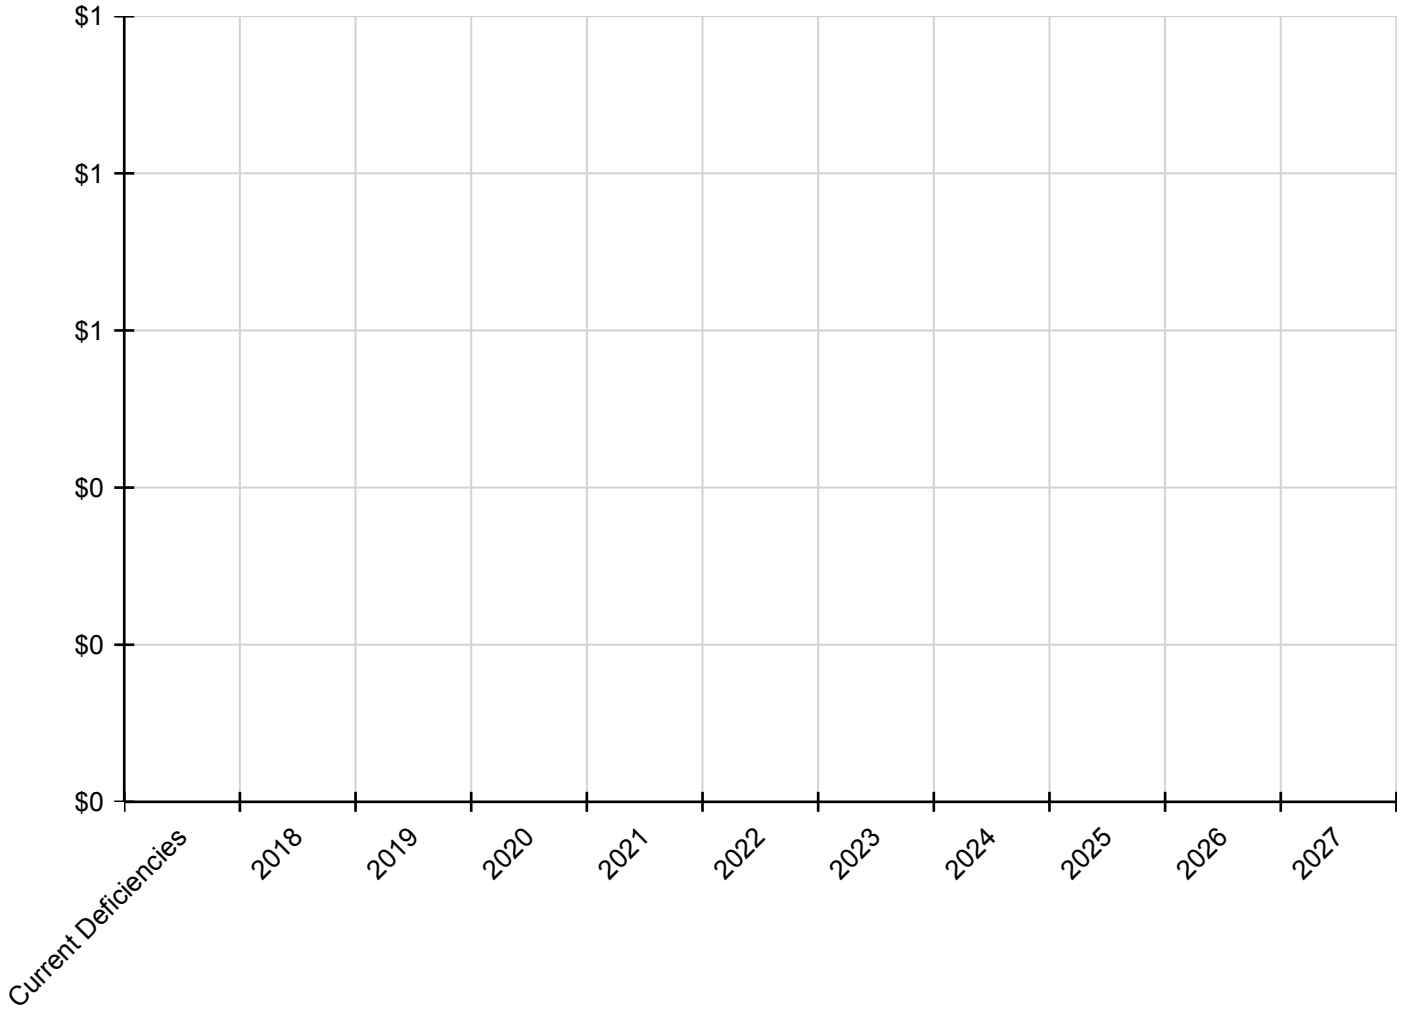
Forecasted Capital Renewal Requirement

The following chart shows the current building deficiencies and forecasting capital renewal or sustainment requirements over the next ten years.

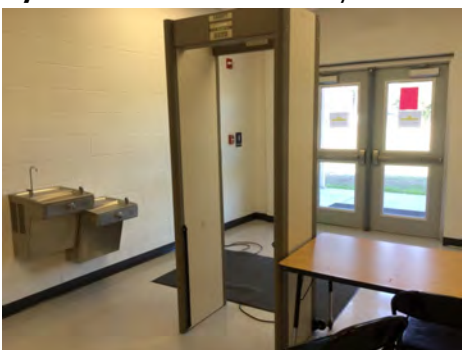
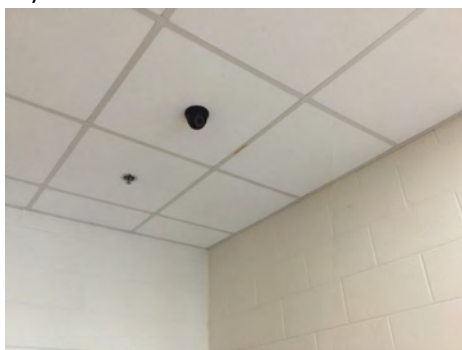
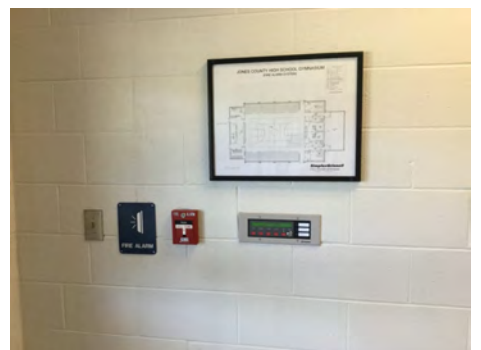
System: D5030810 - Security & Detection Systems

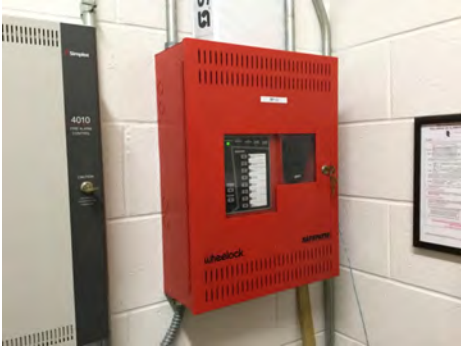
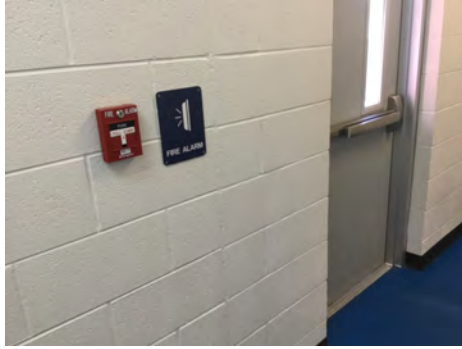
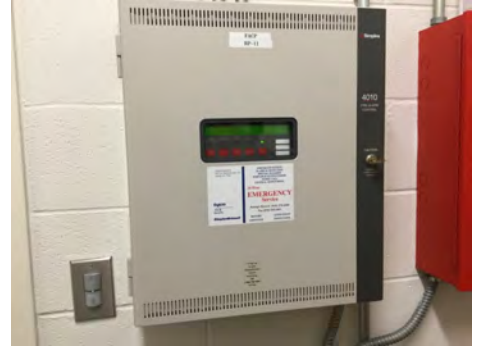
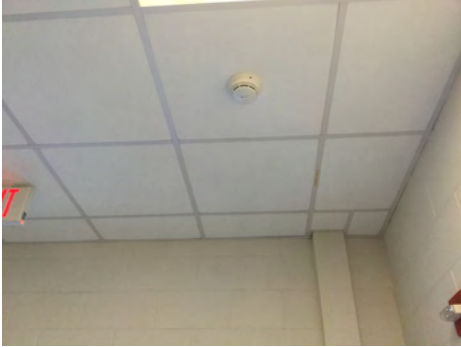
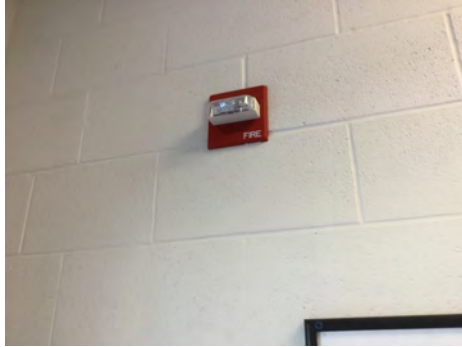
System: D5030910 - Fire Alarm Systems

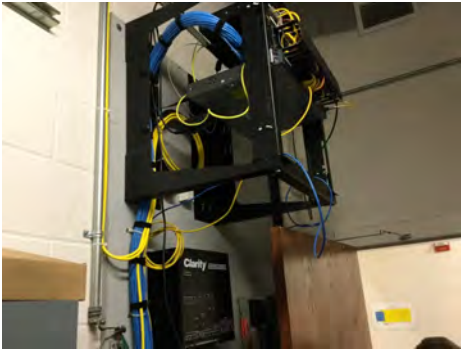
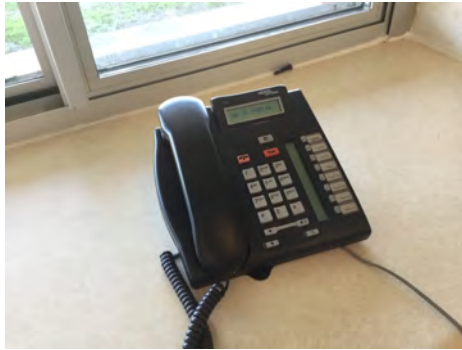
System: D5030920 - Data Communication

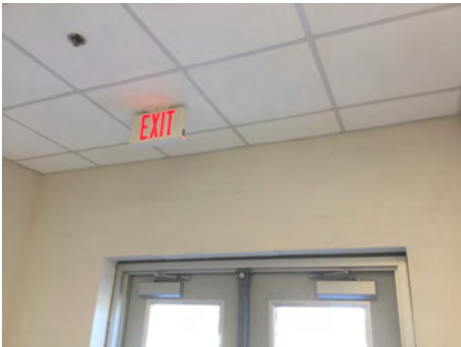
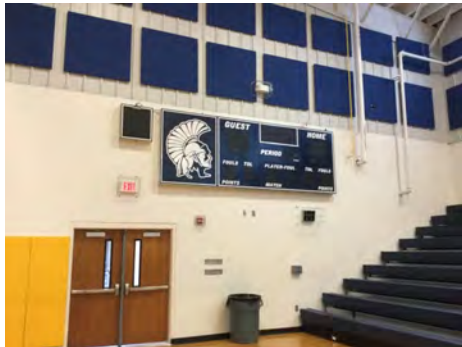
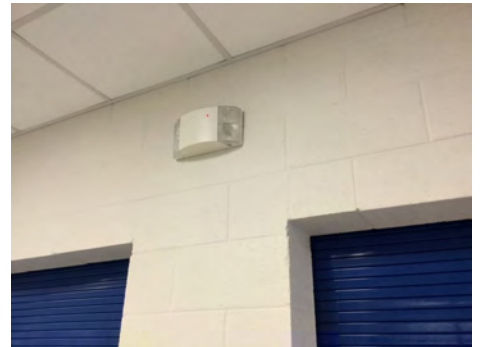
System: D5090 - Other Electrical Systems

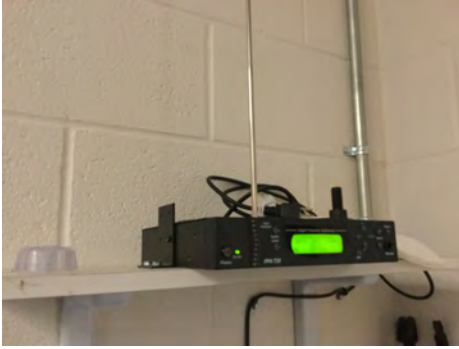
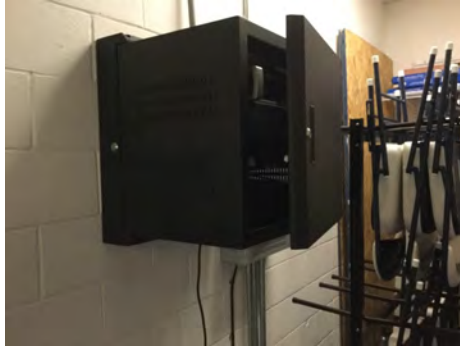
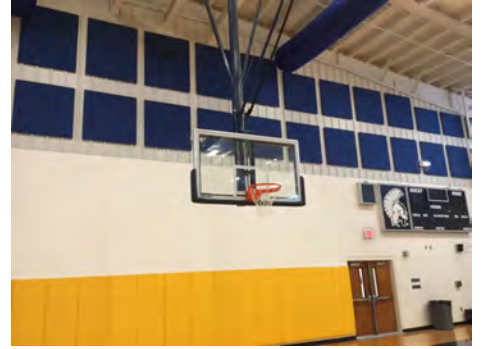
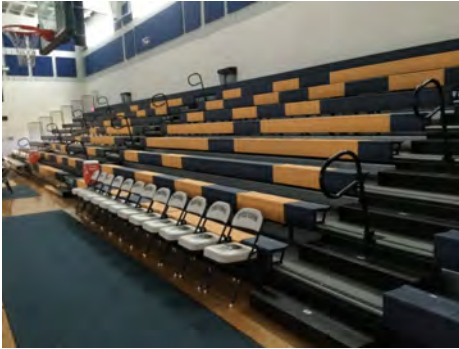
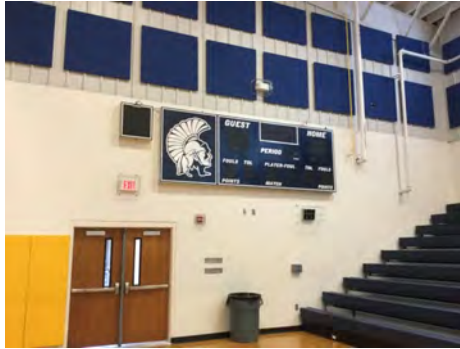
System: E1020 - Institutional Equipment

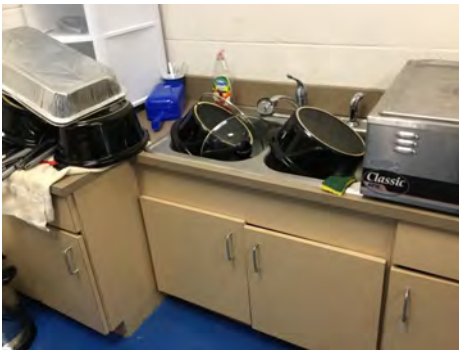
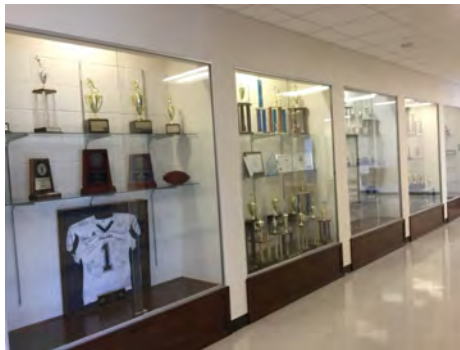
System: E2010 - Fixed Furnishings

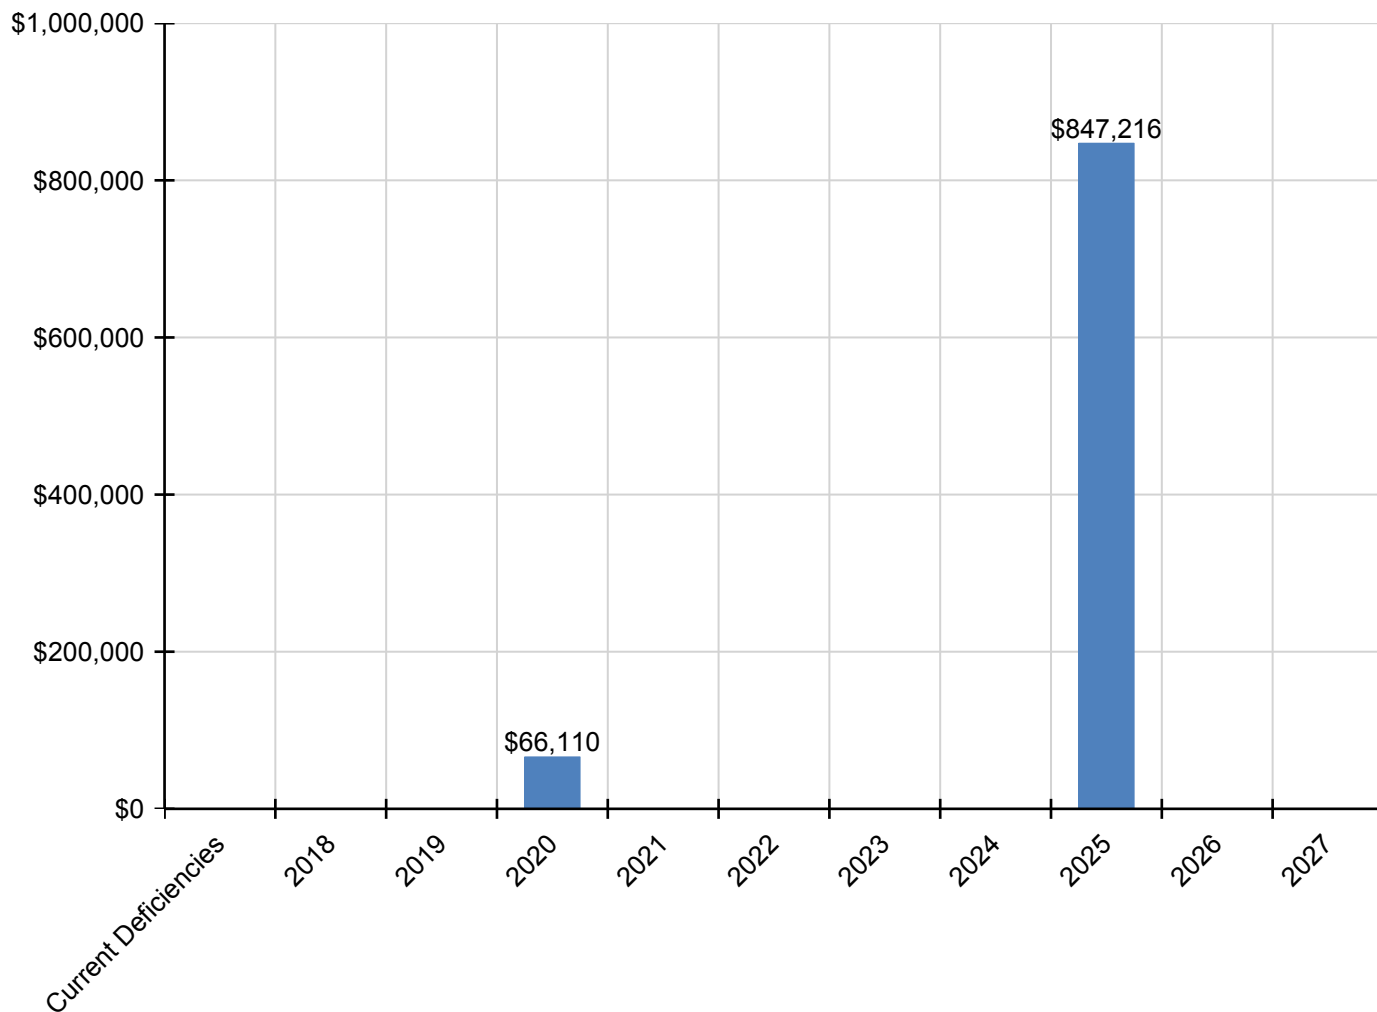
Forecasted Capital Renewal Requirement

The following chart shows the current building deficiencies and forecasting capital renewal or sustainment requirements over the next ten years.

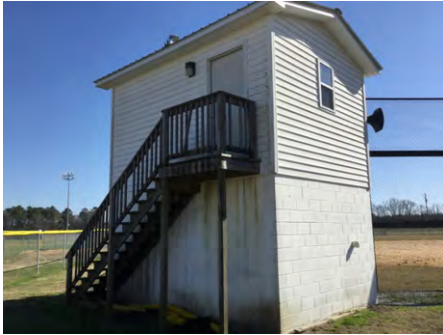
1). Northeast Elevations - Feb 21, 2017

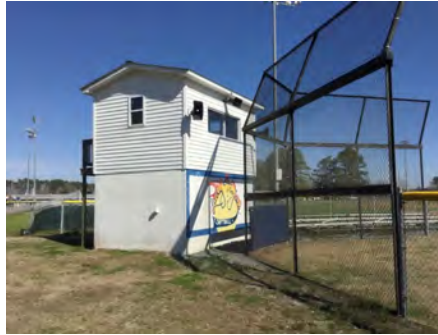
2). Southeast Elevations - Feb 21, 2017

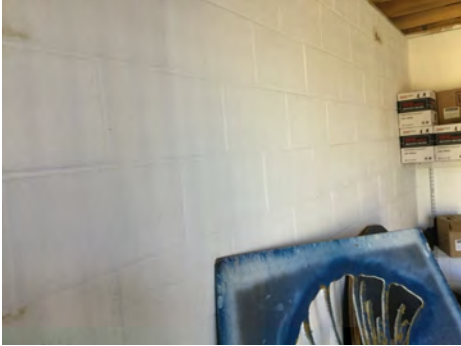
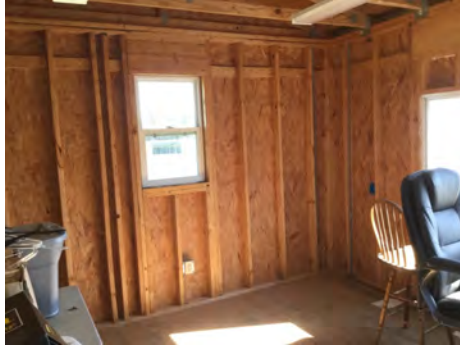
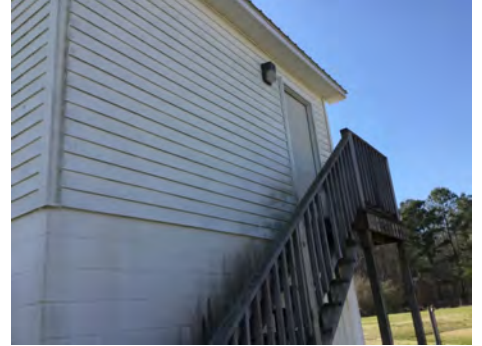
System: B2010 - Exterior Walls

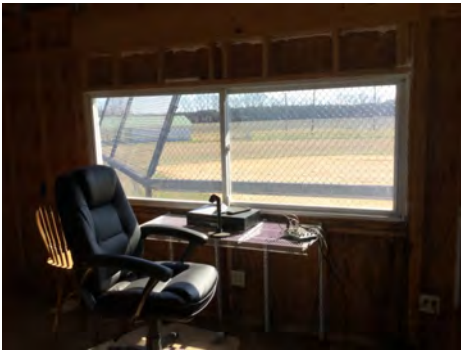
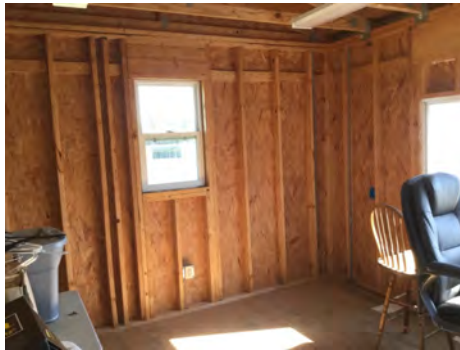
System: B2020 - Exterior Windows

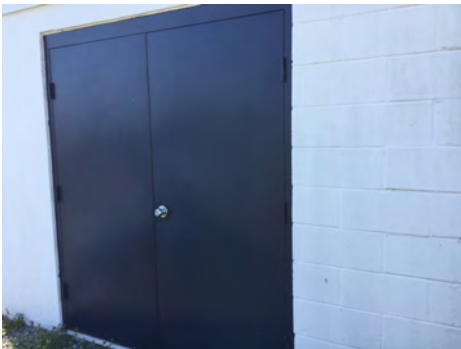
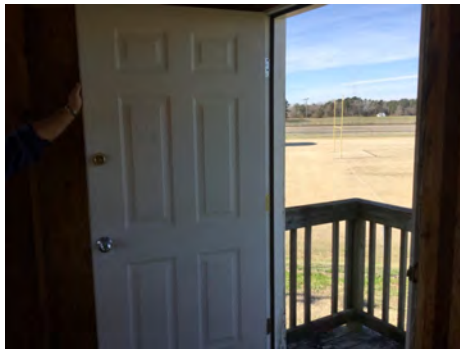
System: B2030 - Exterior Doors

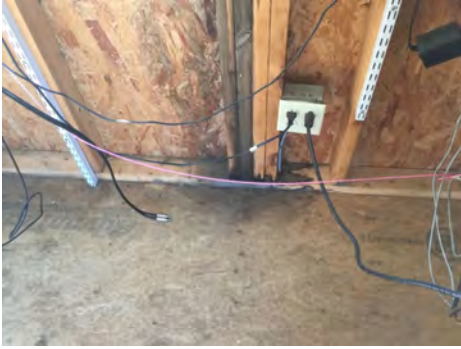
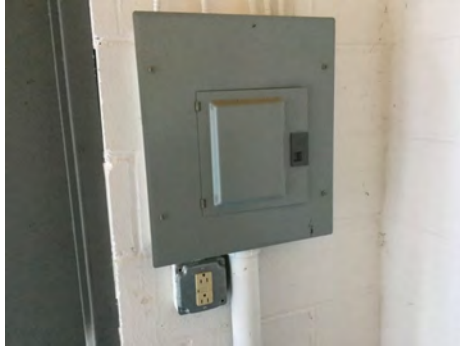
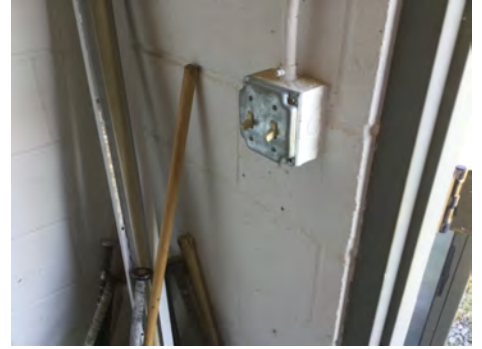
System: D5020 - Branch Wiring

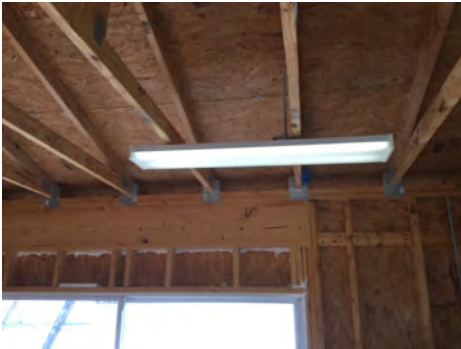
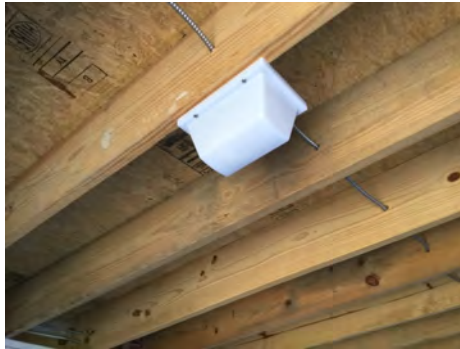
System: D5020 - Lighting

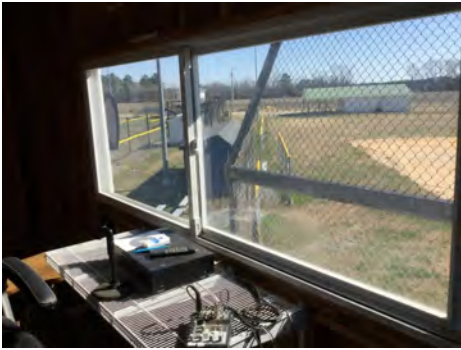
System: E2010 - Fixed Furnishings

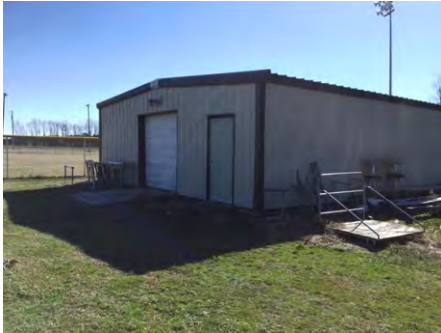
1). Northeast Elevation - Feb 21, 2017

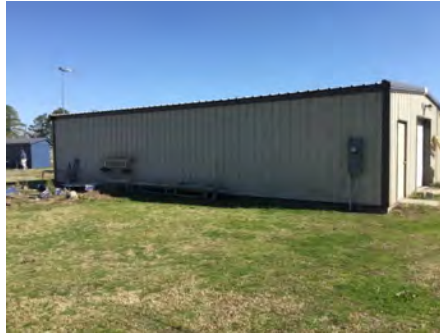
2). Northwest Elevation - Feb 21, 2017

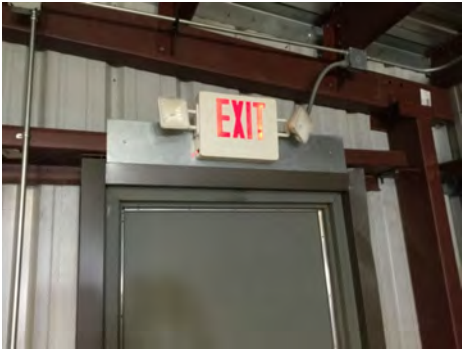
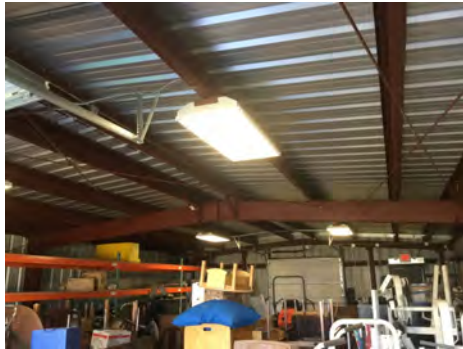
System: D5020 - Lighting

Note: Includes egress lighting and emergency exit signage

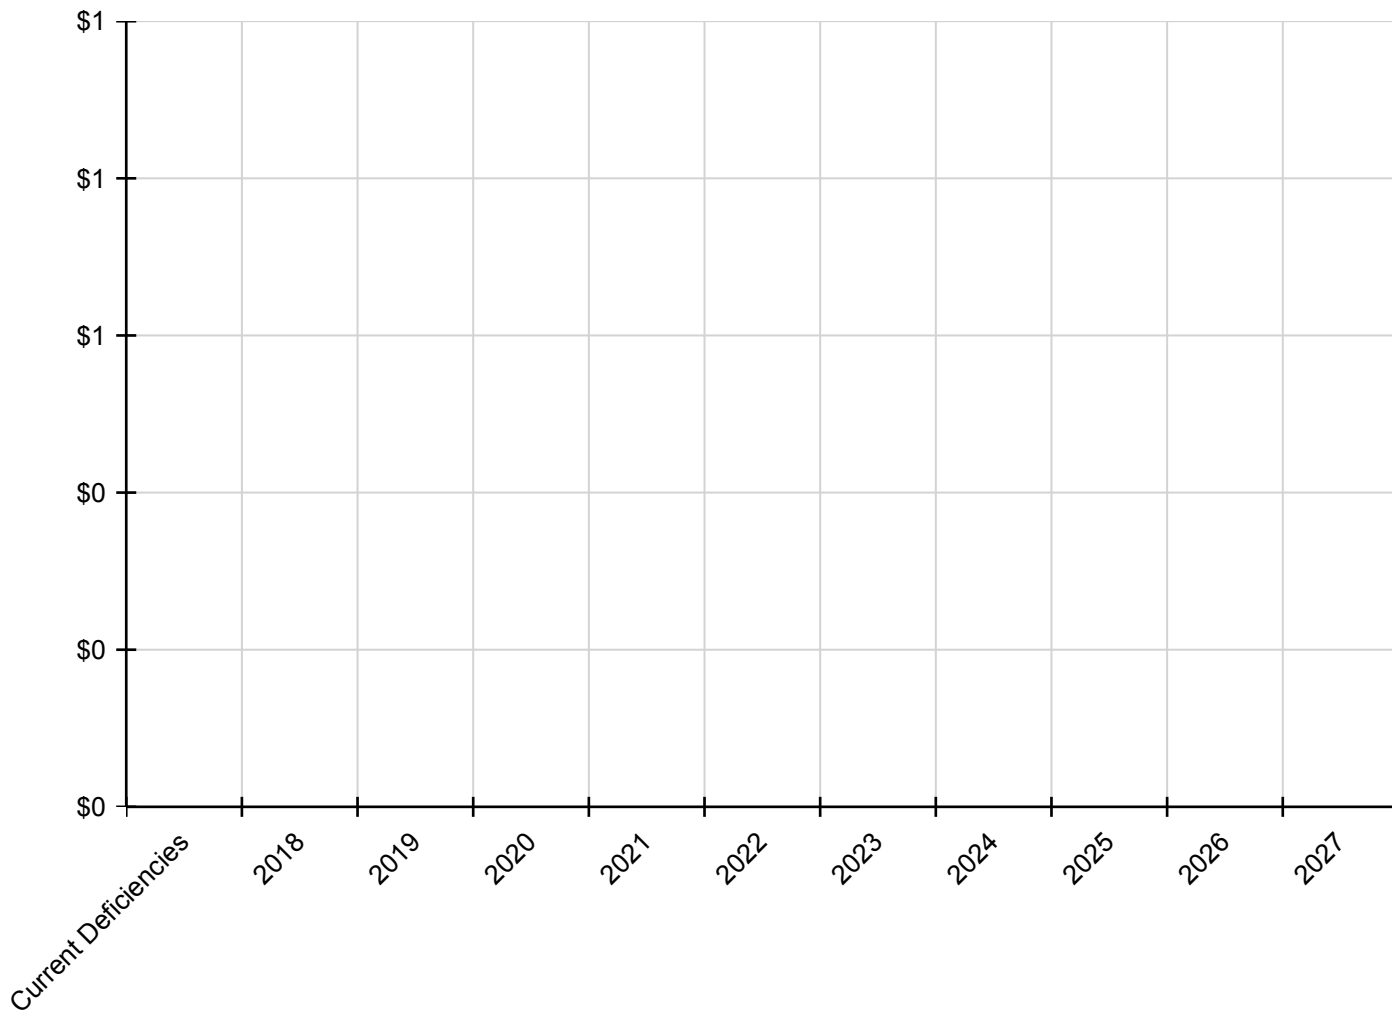
Forecasted Capital Renewal Requirement

The following chart shows the current building deficiencies and forecasting capital renewal or sustainment requirements over the next ten years.

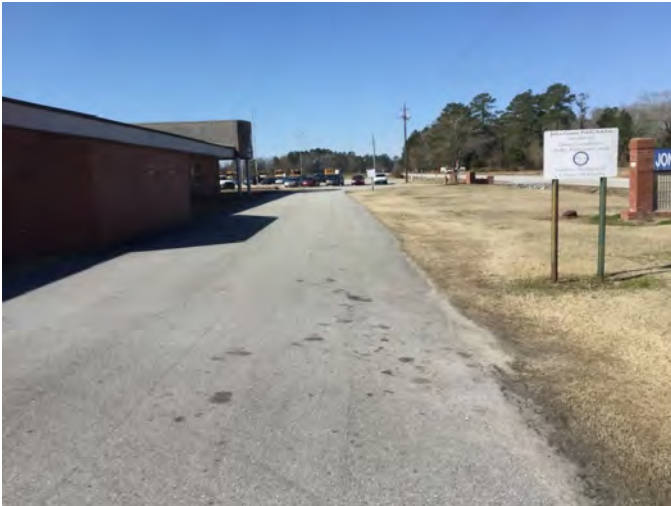
System: G2010 - Roadways

Location: Site
Distress: Beyond Service Life
Category: Deferred Maintenance
Priority: 3 - Necessary/Not Yet Critical (Years 2-5)
Correction: Renew System
Qty: 96,039.00
Unit of Measure: S.F.
Estimate: \$397,217.00
Assessor Name: Terence Davis
Date Created: 02/17/2017

Notes: Roadways are in worn condition. The service road at the east end of the site is unpaved. System renewal is recommended.

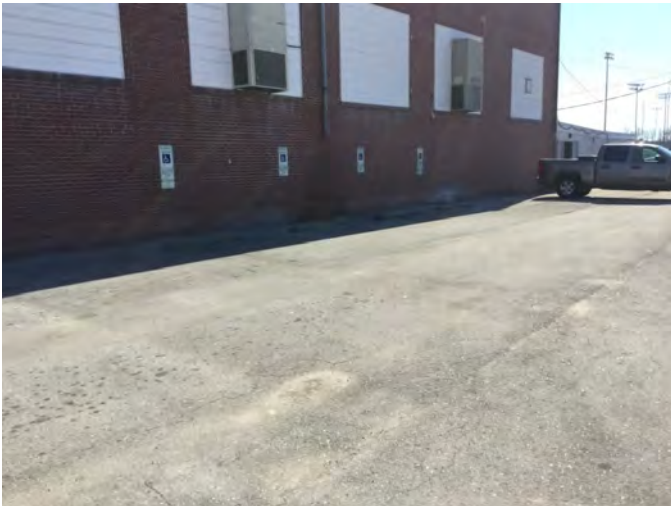
System: G2020 - Parking Lots

Location: Parking lots
Distress: Beyond Service Life
Category: Deferred Maintenance
Priority: 3 - Necessary/Not Yet Critical (Years 2-5)
Correction: Renew System
Qty: 96,039.00
Unit of Measure: S.F.
Estimate: \$170,085.00
Assessor Name: Terence Davis
Date Created: 02/17/2017

Notes: Parking lots, particularly the east parking lot, are in worn condition. The paving surface is uneven. Striping is faded. Edges are not curbed. Drainage patterns should be studied. System renewal is recommended.

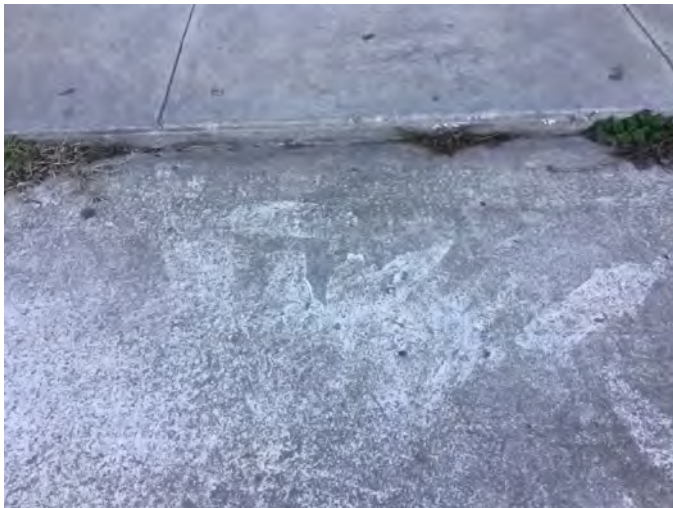
System: G2030 - Pedestrian Paving

Location: Site
Distress: Beyond Service Life
Category: Deferred Maintenance / Safety
Priority: 3 - Necessary/Not Yet Critical (Years 2-5)
Correction: Renew System
Qty: 96,039.00
Unit of Measure: S.F.
Estimate: \$209,173.00
Assessor Name: Terence Davis
Date Created: 02/17/2017

Notes: Sidewalks are in fair to poor condition, particularly around the main, ag, and media buildings. Differential settlement and cracking creates tripping hazards. System renewal is recommended.

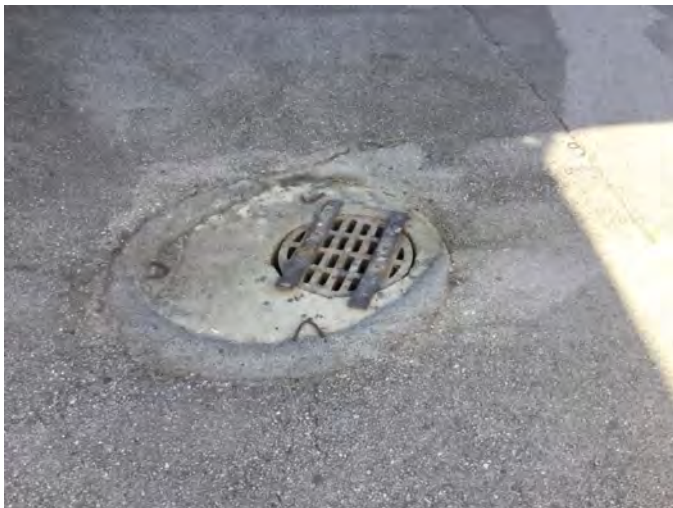
System: G3030 - Storm Sewer

Location: Site
Distress: Inadequate
Category: Deferred Maintenance
Priority: 3 - Necessary/Not Yet Critical (Years 2-5)
Correction: Renew System
Qty: 96,039.00
Unit of Measure: S.F.
Estimate: \$493,352.00
Assessor Name: Terence Davis
Date Created: 02/17/2017

Notes: Storm sewer facilities around the site are in adequate, leading to ponding in high traffic areas. System study and renewal is recommended.
