NC School District/520 Jones County/High School

Jones Senior High

Campus Assessment Report

March 11, 2017

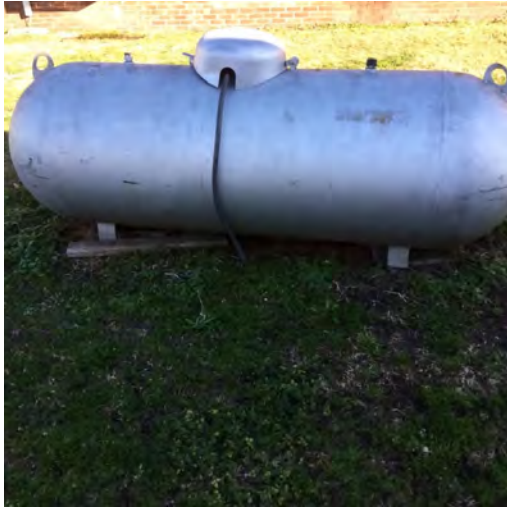
System: G3060 - Fuel Distribution

Location: Site
Distress: Beyond Service Life
Category: Deferred Maintenance
Priority: 3 - Necessary/Not Yet Critical (Years 2-5)
Correction: Renew System
Qty: 96,039.00
Unit of Measure: S.F.
Estimate: \$108,812.00
Assessor Name: Terence Davis
Date Created: 02/17/2017

Notes: Fuel distribution facilities are of varying age across the site, but in general are beyond their expected useful life. System renewal is recommended.

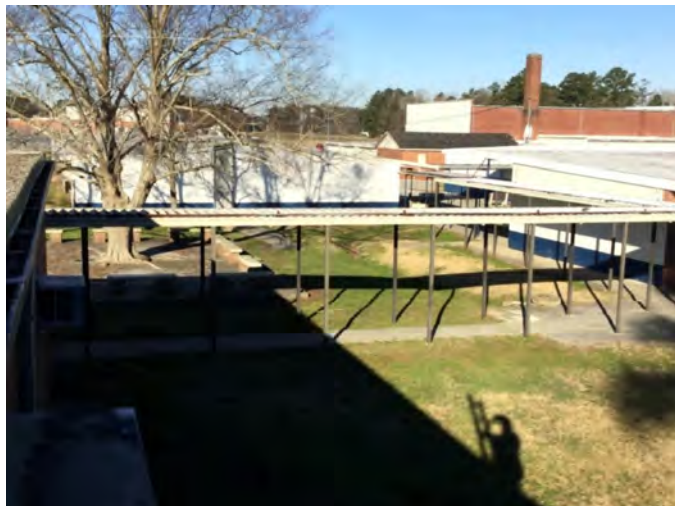
System: G2040950 - Covered Walkways

Location: Site
Distress: Beyond Service Life
Category: Deferred Maintenance
Priority: 4 - Recommended (Years 6-10)
Correction: Renew System
Qty: 96,039.00
Unit of Measure: S.F.
Estimate: \$85,571.00
Assessor Name: Terence Davis
Date Created: 02/17/2017

Notes: Covered walkways are in fair condition and beyond their expected useful life. System renewal is recommended.
