NC School District/830 Scotland County/Middle School

Spring Hill Middle

Campus Assessment Report

March 11, 2017

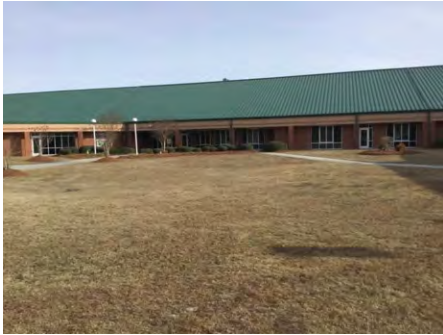
1). West Elevation - Jan 11, 2017

The photo album consists of the various cardinal directions of the building..

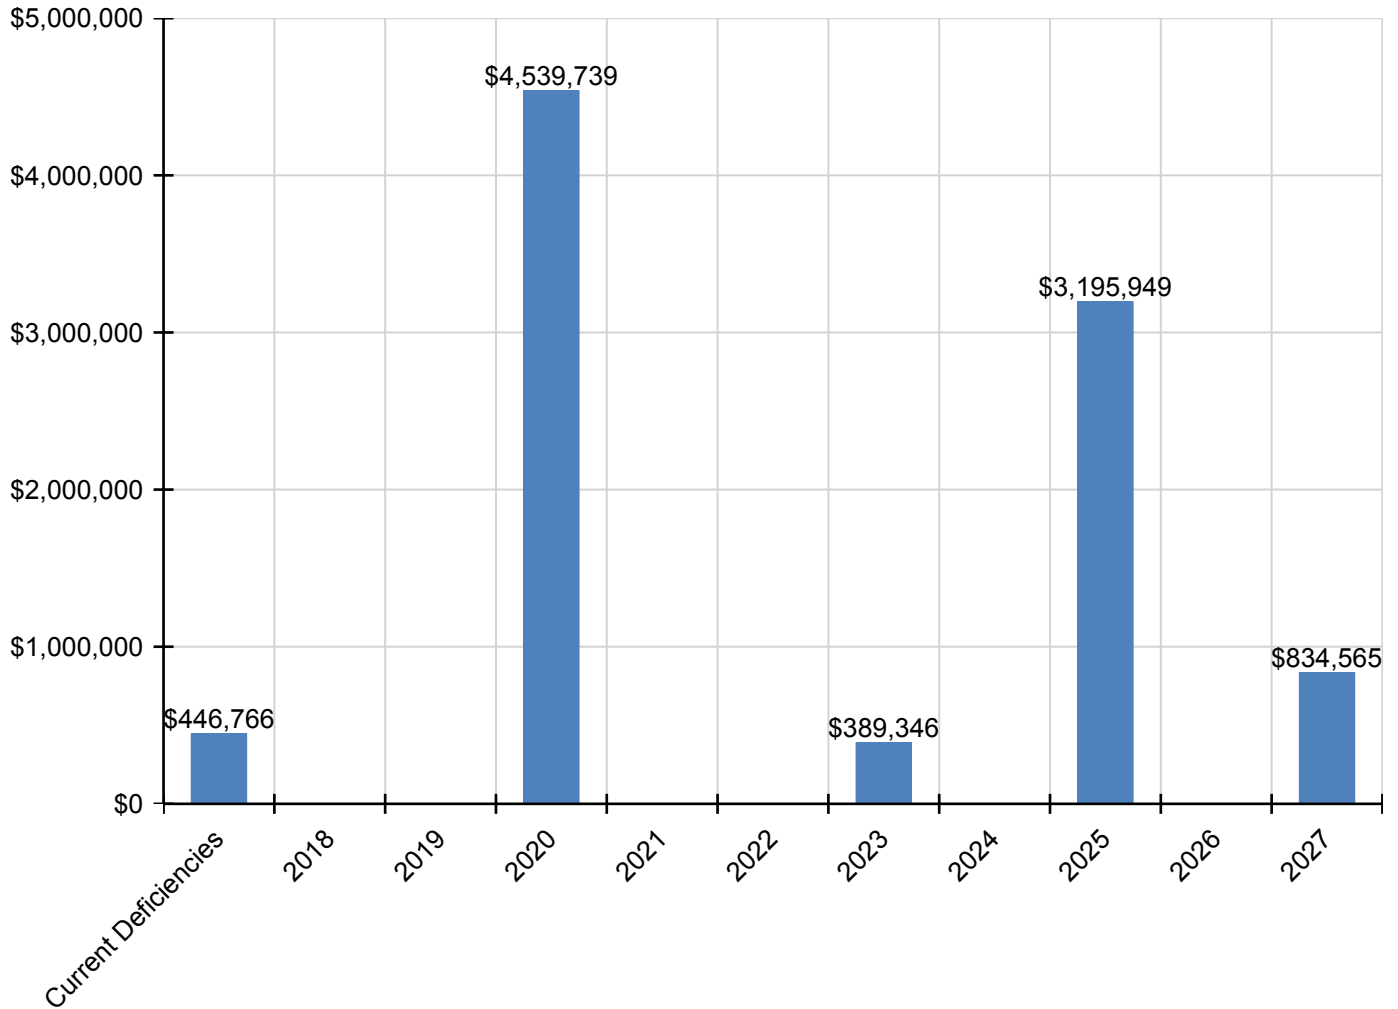
Forecasted Capital Renewal Requirement

The following chart shows the current building deficiencies and forecasting capital renewal or sustainment requirements over the next ten years.

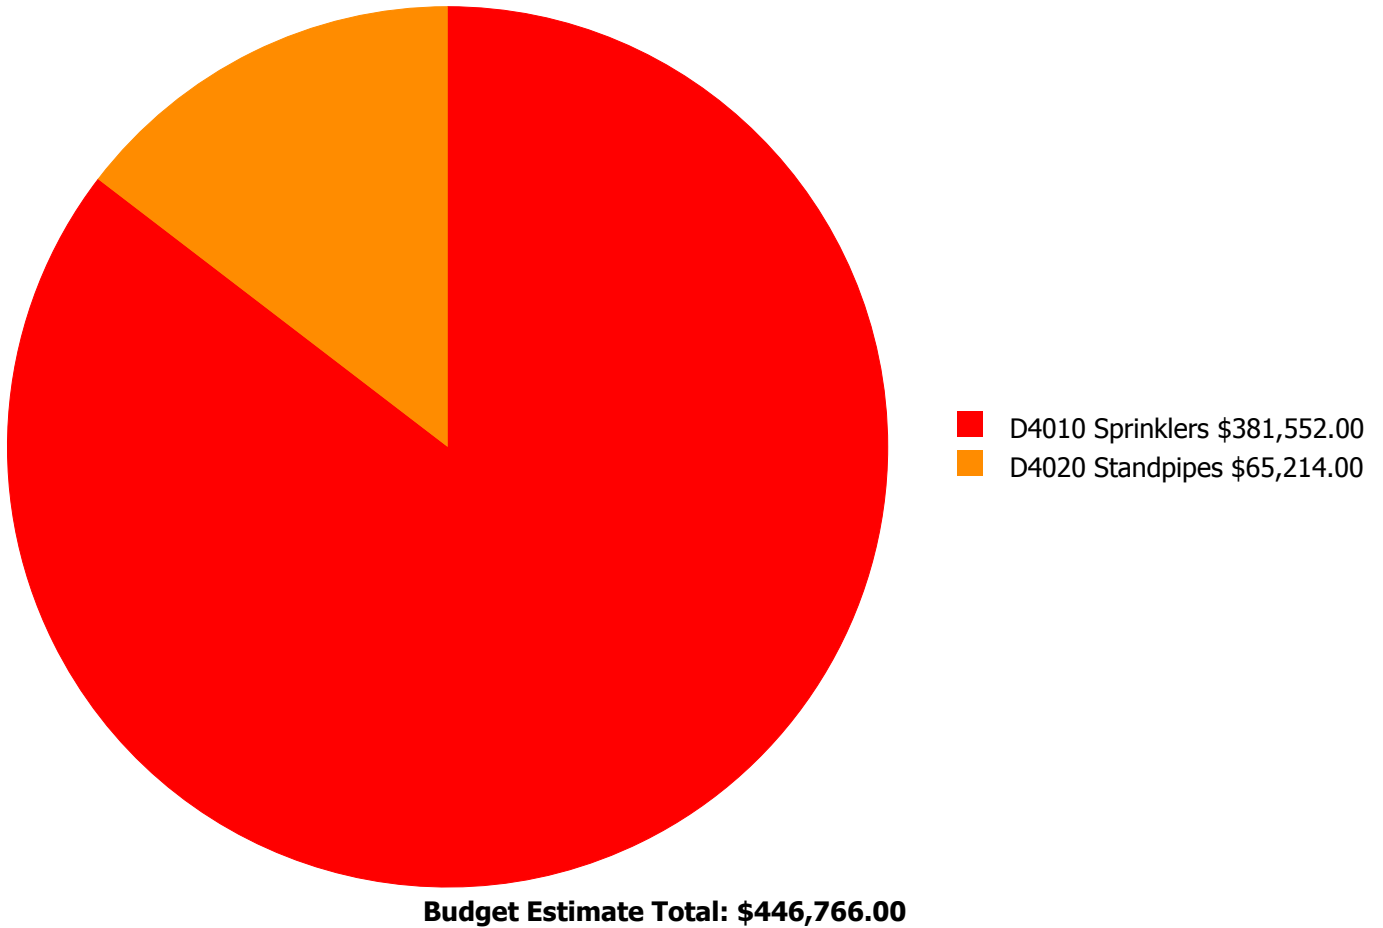
Deficiency Summary by System

Current deficiencies included assemblies that have reached or exceeded their design life or components of the assemblies that are in need of repair. Assemblies that have reached their design life are identified as current deficiencies and assigned the distress 'Beyond Useful Life'. The following chart lists all current deficiencies associated with this facility.

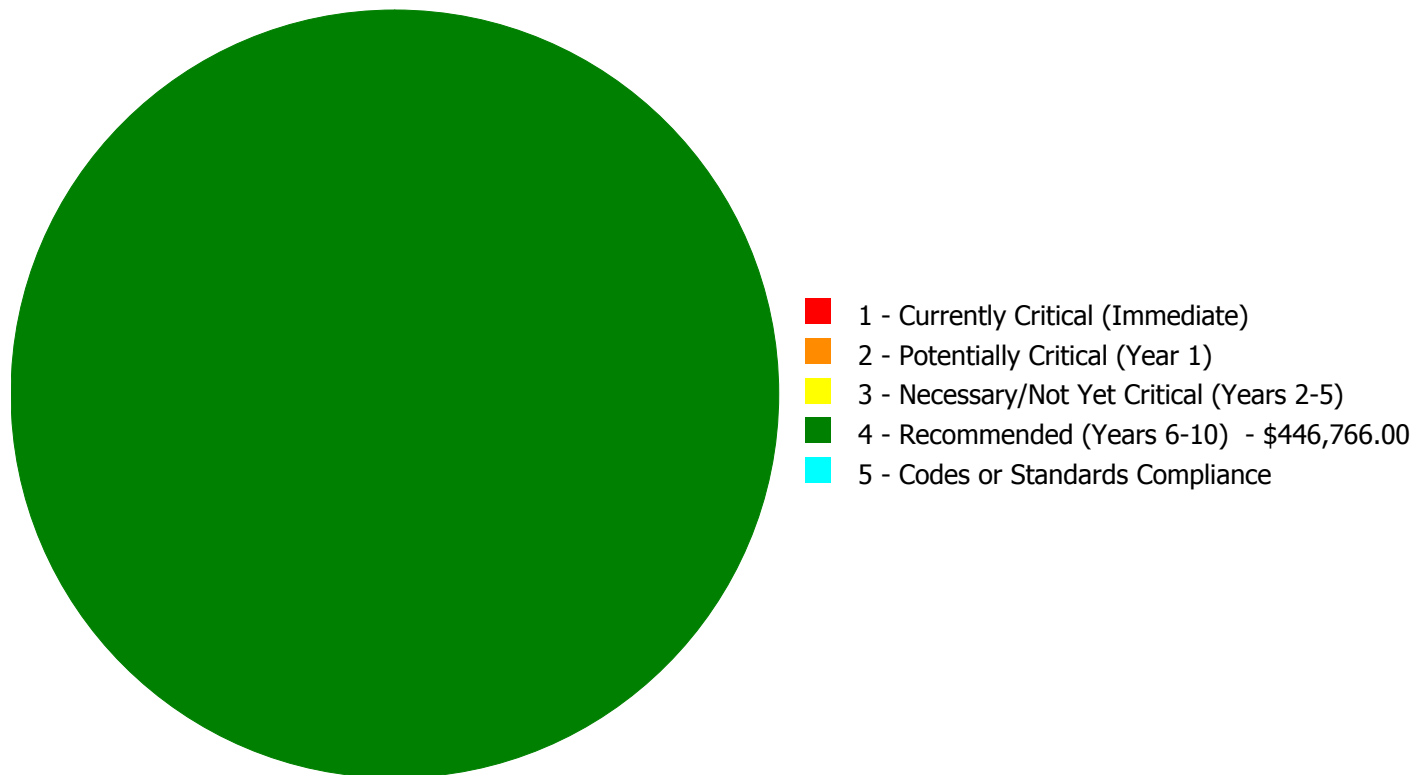
Deficiency Summary by Priority

The following chart shows the total repair costs broken down by priority. Assessors assigned deficiencies within eCOMET to one of the following priority categories:

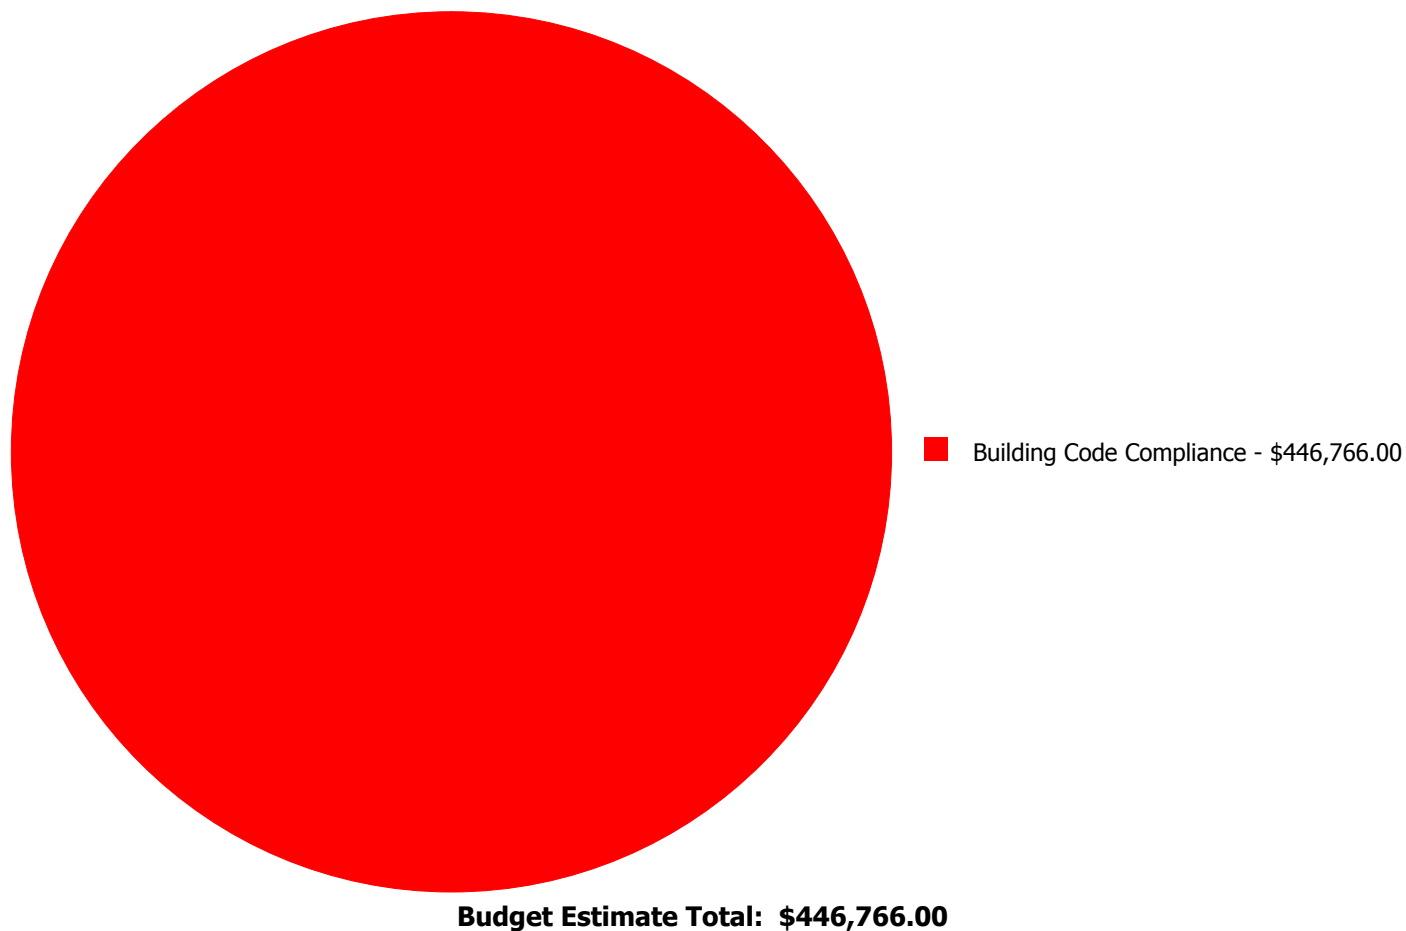
Deficiency Summary by Category

The following chart shows the total repair costs broken down by deficiency categories. Assessors assigned deficiencies to one of the following categories:

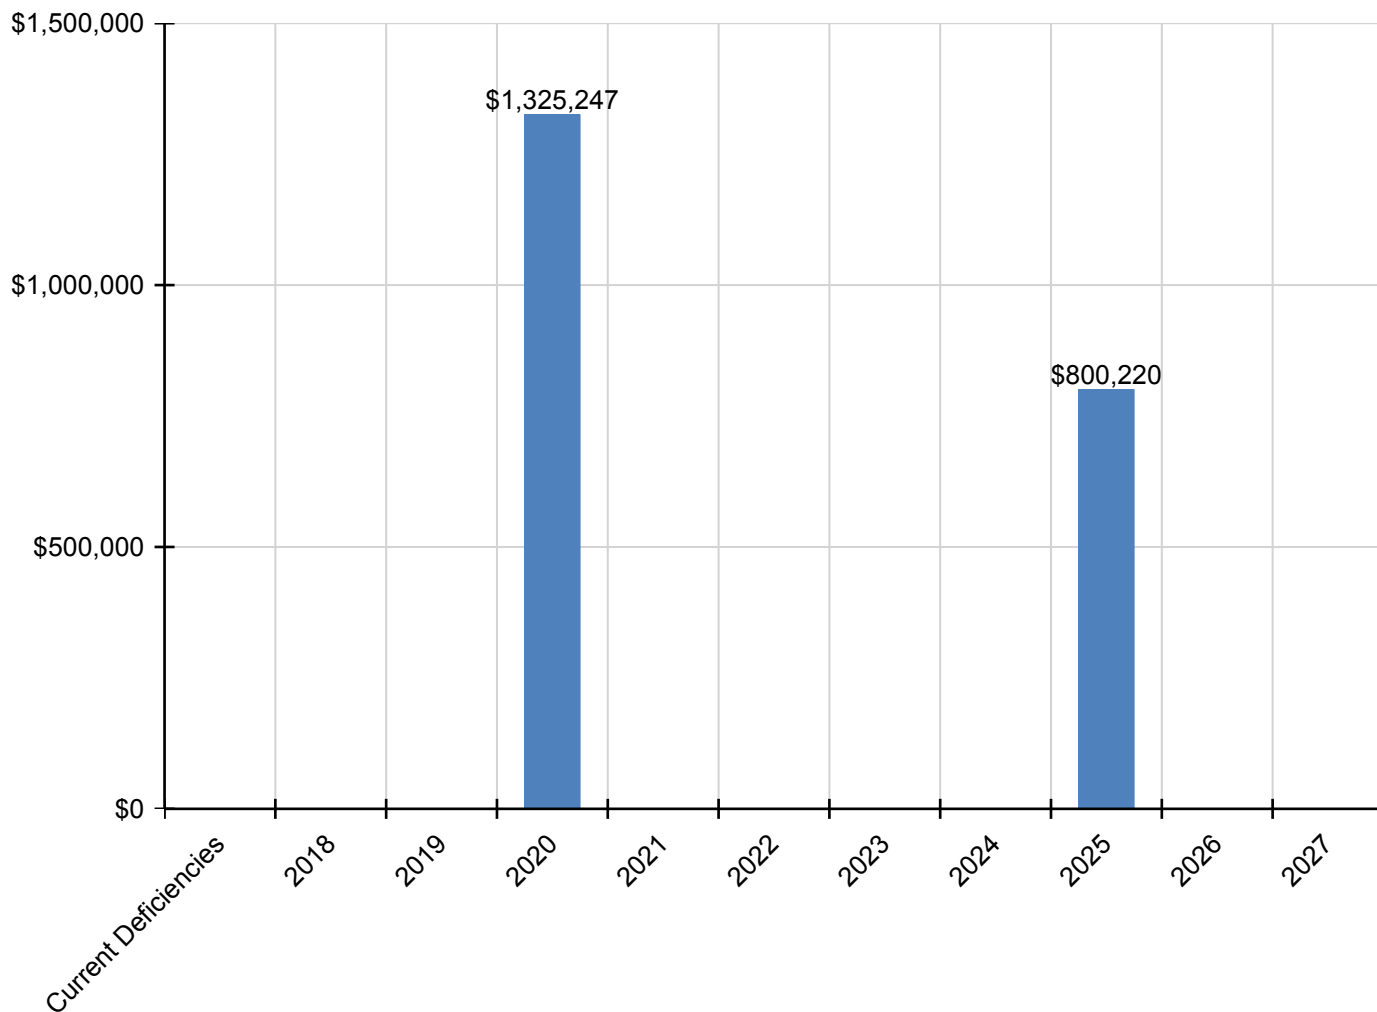
Forecasted Capital Renewal Requirement

The following chart shows the current building deficiencies and forecasting capital renewal or sustainment requirements over the next ten years.

eCOMET forecasts future Capital Renewal projects for expiring systems based on the Calculated Next Renewal year found in the system listing. There is a 3% yearly inflation factor applied to the system costs expiring in the future. The table below reflects Capital Renewal projects over the next 10 years. Note: Blank cells (or \$0) indicate no systems are scheduled for renewal in that year.
