NC School District/430 Harnett County/Elementary School

# Anderson Creek Primary

## Campus Assessment Report

March 11, 2017

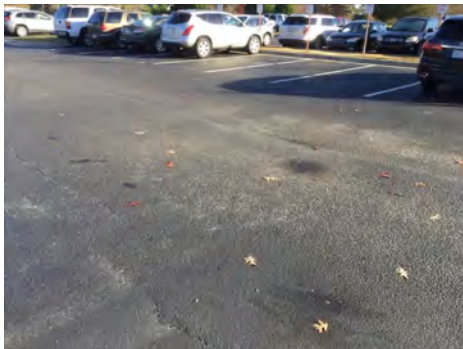
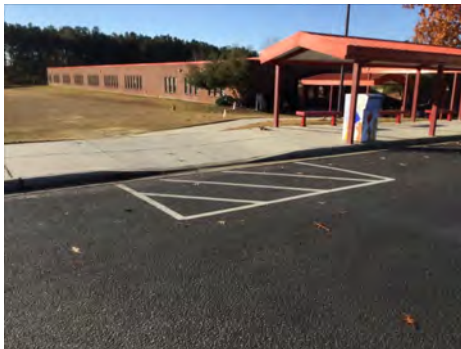
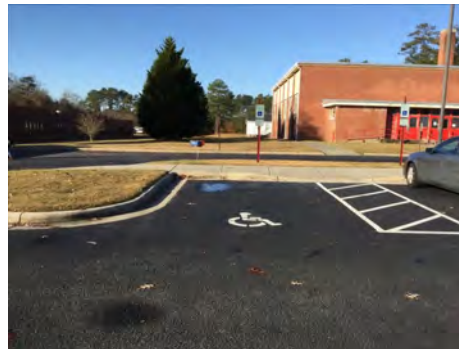
**System:** G2020 - Parking Lots

**Note:** Seal coated in 2015
