NC School District/040 Anson County/Elementary School

Ansonville Elementary

Campus Assessment Report

March 11, 2017

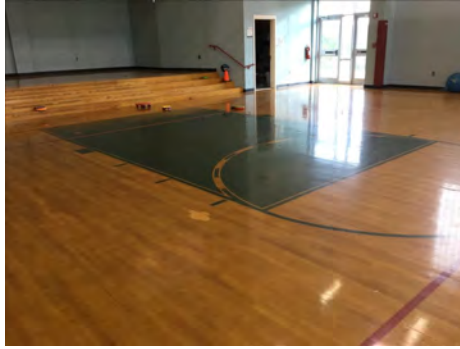
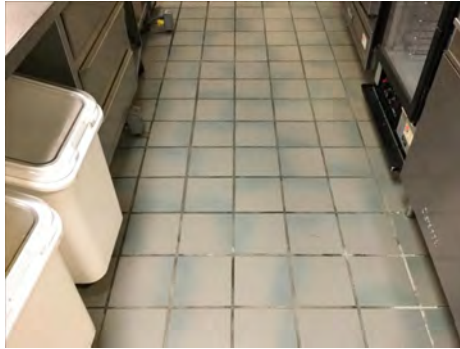
System: C3020 - Floor Finishes

Note: Carpet needs to be replaced. 2% of VCT needs to be replaced.

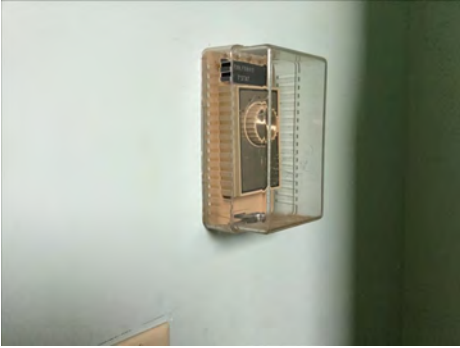
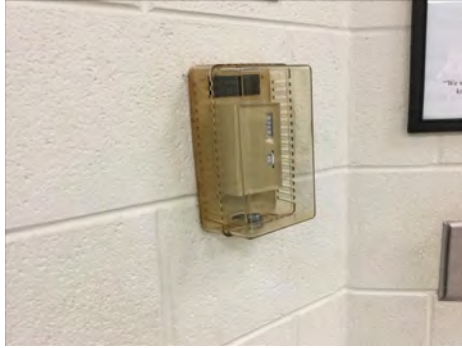
System: D3060 - Controls & Instrumentation

Note: The controls and instrumentation system is beyond its service life and should be replaced.

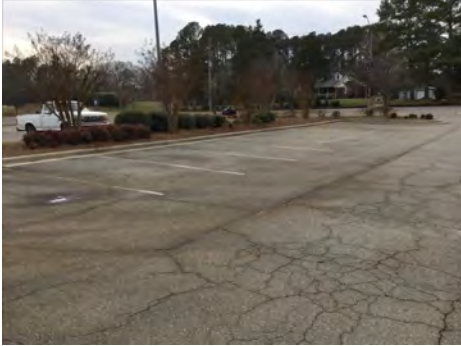
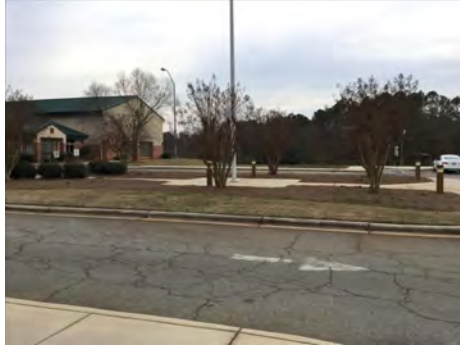
System: G2010 - Roadways

Note: The roadways are beyond their service life and should be replaced.
