NC School District/430 Harnett County/Elementary School

# Boone Trail Elementary

## Campus Assessment Report

March 11, 2017

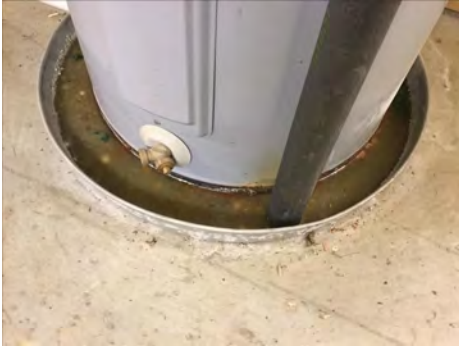
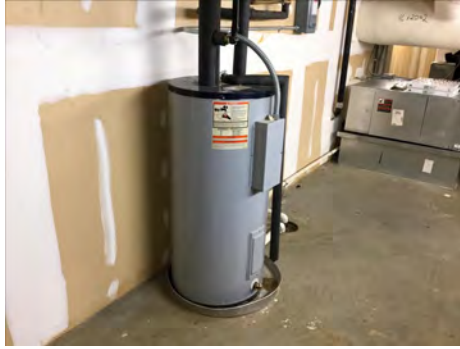
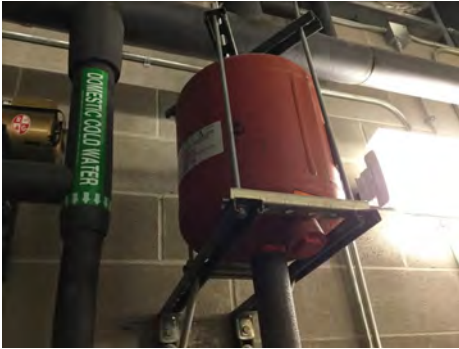
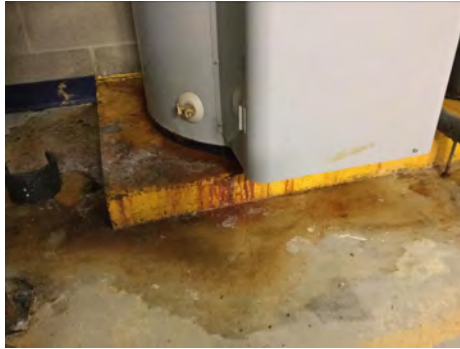
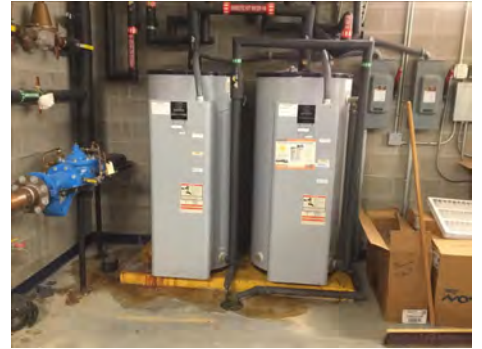
**System:** D2020 - Domestic Water Distribution

**Note:** 4 - water heaters are at the end of there life cycle.
