NC School District/520 Jones County/Elementary School

Comfort Elementary

Campus Assessment Report

March 11, 2017

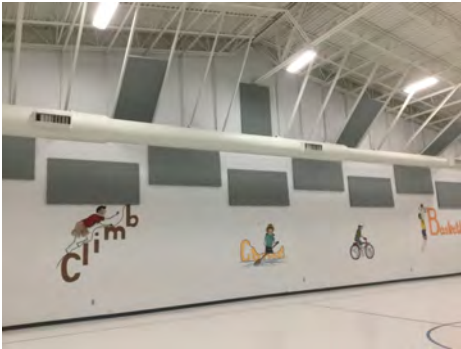
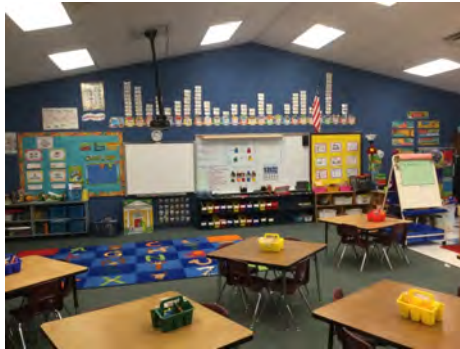
System: C3010 - Wall Finishes

Note: Interior painting is scheduled for 2017.

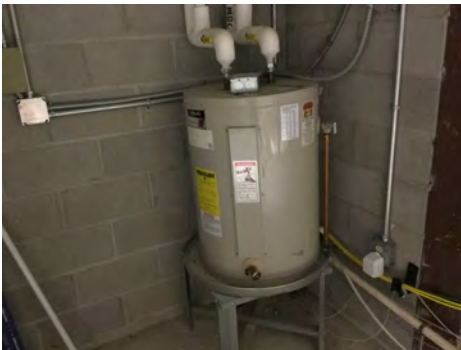
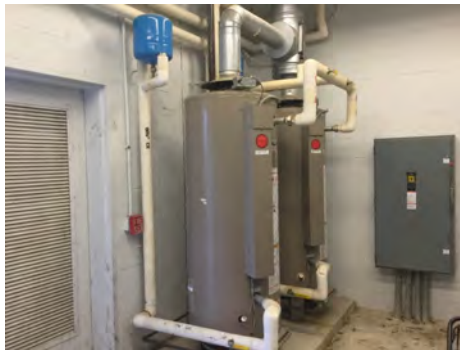
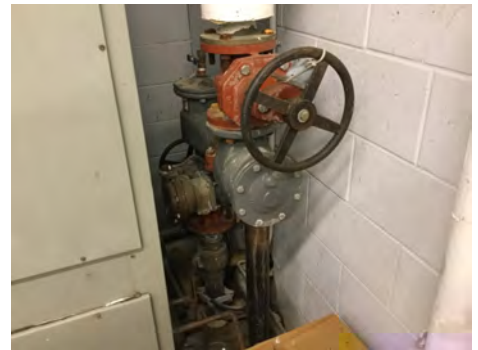
System: D2020 - Domestic Water Distribution

Note: Gas water heaters for kitchen. Electric water heaters elsewhere.

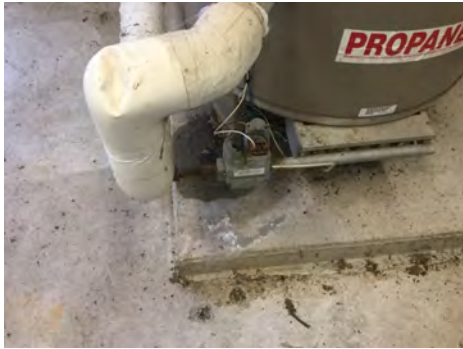
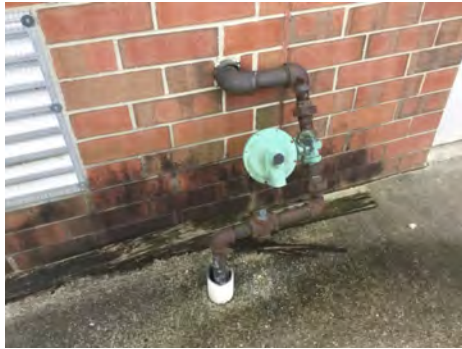
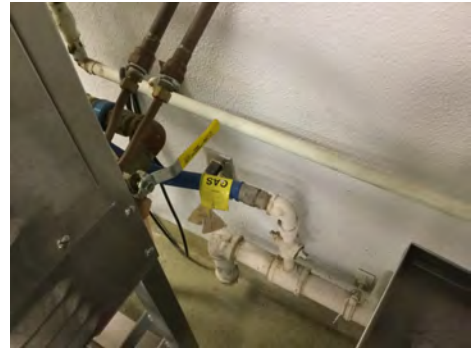
System: D2090 - Other Plumbing Systems -Propane

Note: Cooking fuel and kitchen hot water heaters.

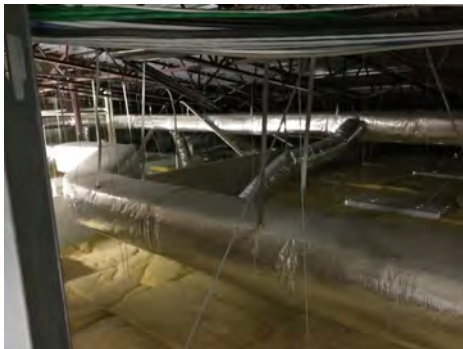
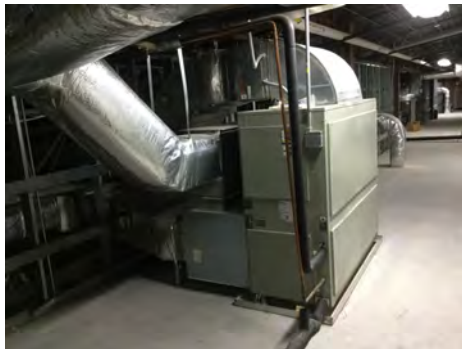
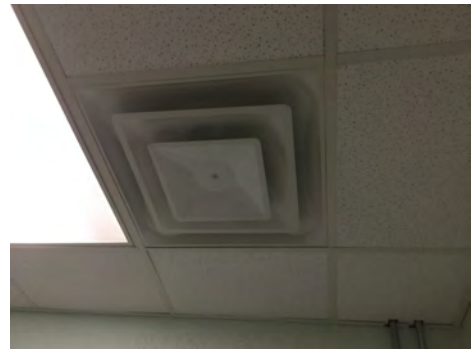
System: D3040 - Distribution Systems

Note: Condensate drain lines are piped to sewer pipes without air gap.

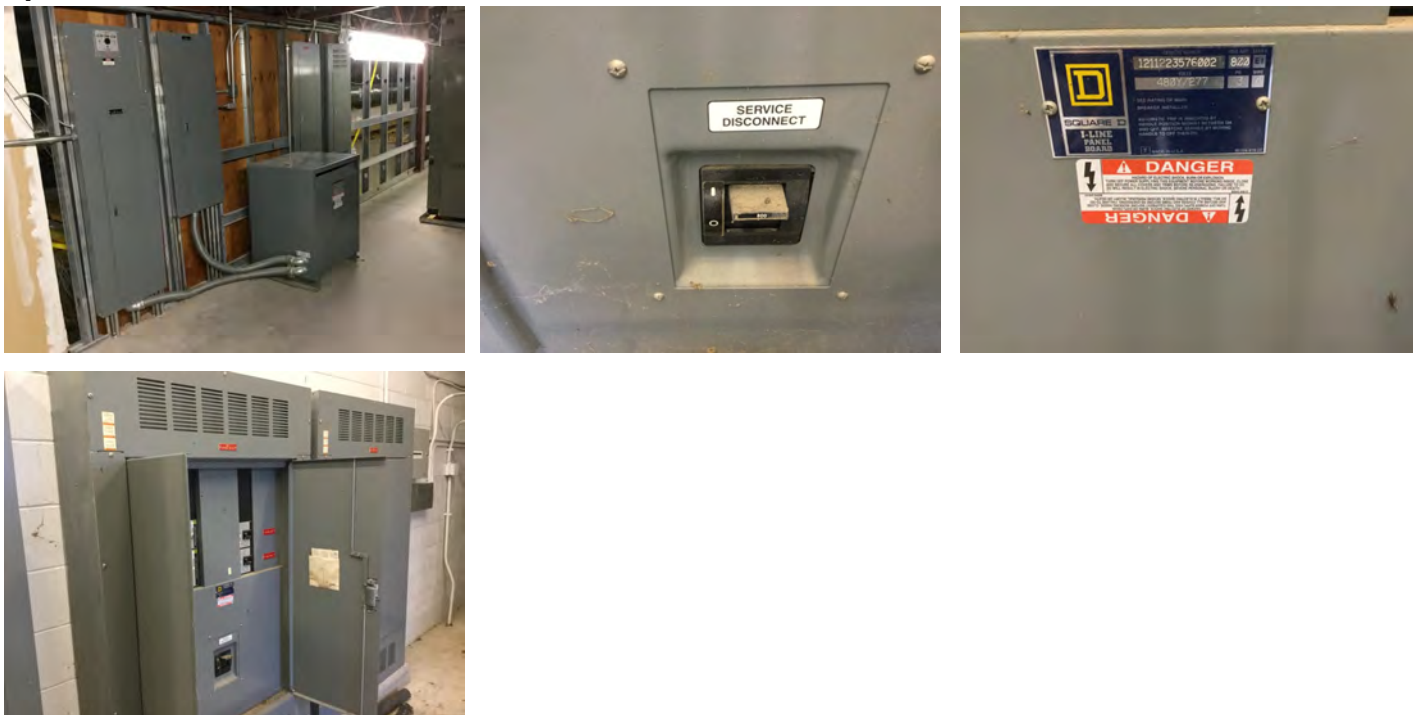
System: D5010 - Electrical Service/Distribution

Note: Two 800 amps services in parallel.

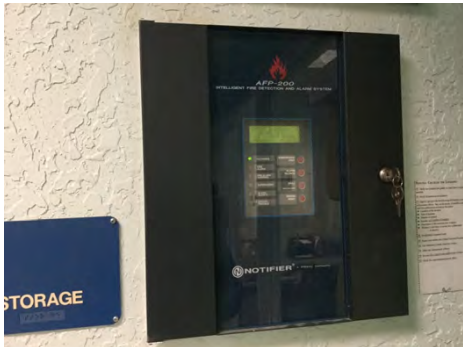
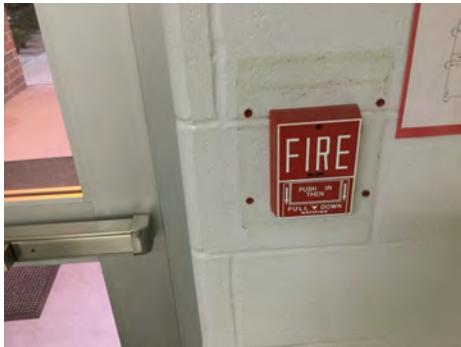
System: D5030910 - Fire Alarm Systems

Notes: The fire alarm system is original and beyond its expected life. System renewal is recommended to ensure reliability of this life safety system.

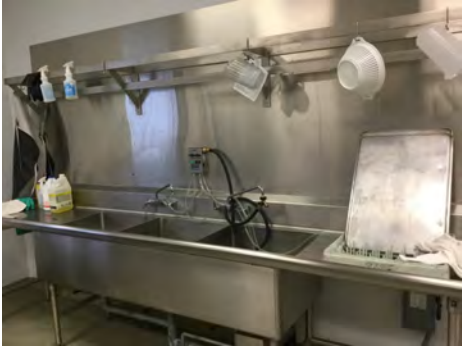
System: E1090 - Other Equipment

Note: Dishwasher abandoned in place.

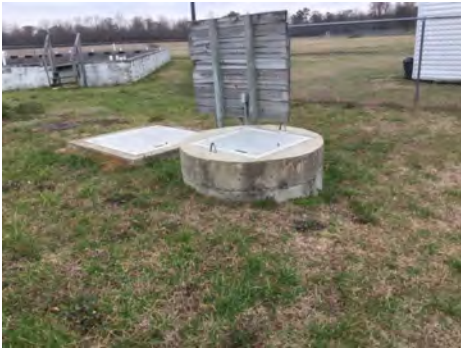
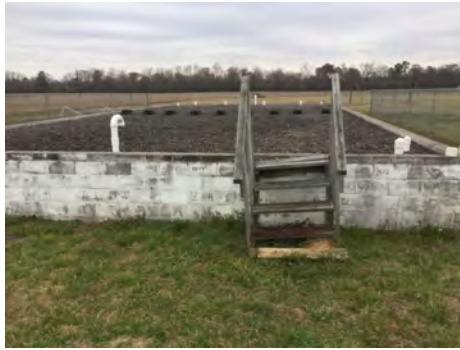
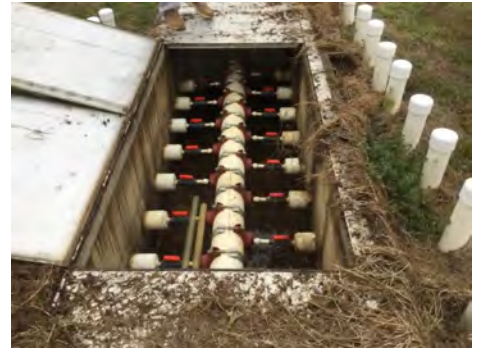
System: G3020 - Sanitary Sewer

Note: Sand filter, lift station, septic field.
