NC School District/430 Harnett County/Elementary School

Harnett Primary

Campus Assessment Report

March 11, 2017

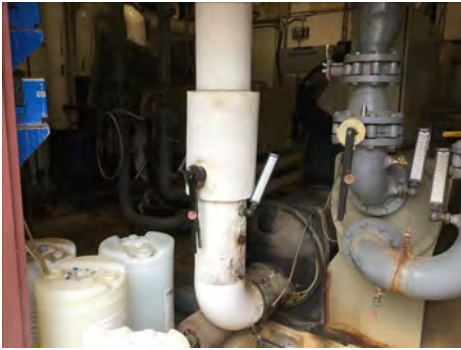
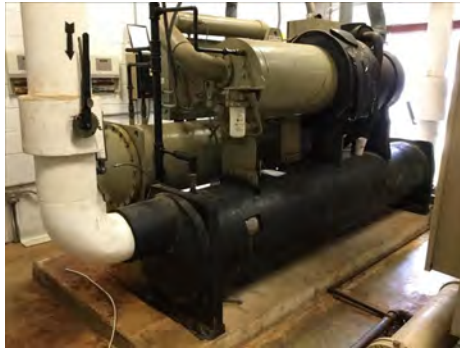
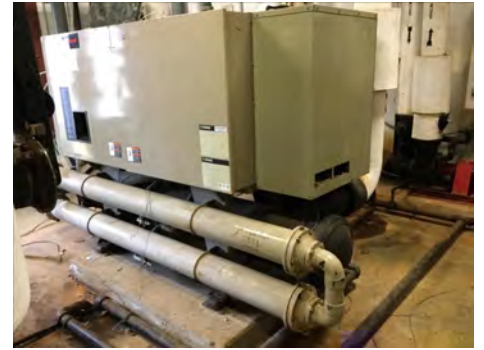
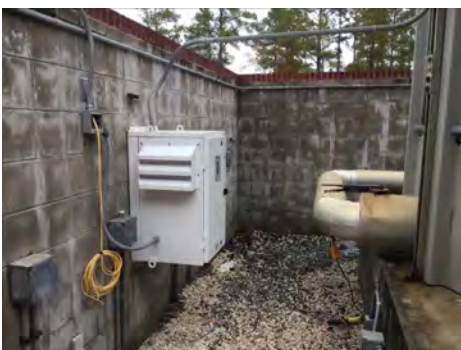
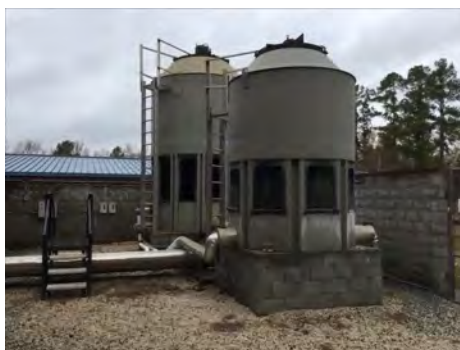
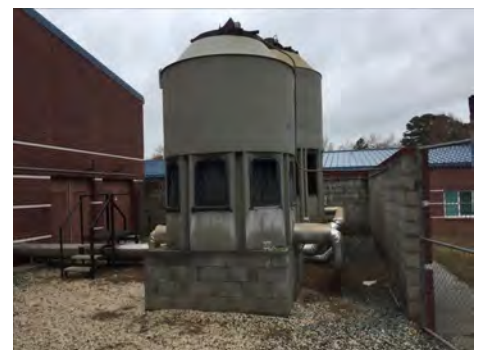
System: D3030 - Cooling Generating Systems

Notes: Chiller is broken.
